FOOTHILL FOREST CARE
CONSULTING ARBORISTS

Arborist Report

The Coast Redwood near the

Courthouse and District Attorney's Office

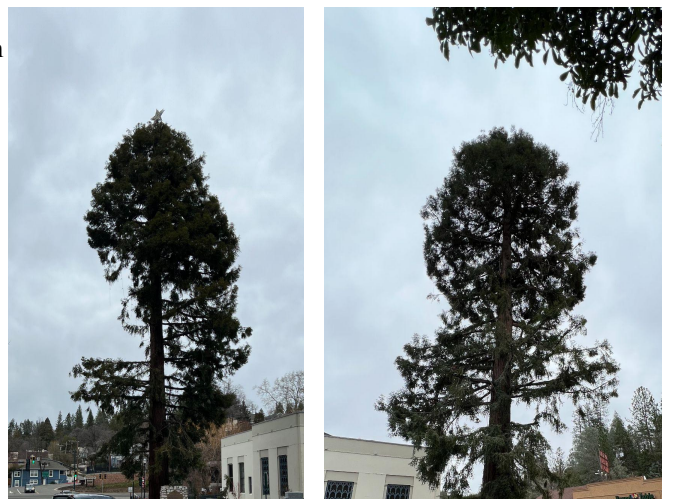
The current appearance of the tree shows a gap in the canopy. There is a branch growing into this negative space. Depending on the viewing angle, the tree's appearance changes drastically.

The current appearance of the tree canopy is uneven from certain viewing angles. The gaps in the tree crown will fill in over time, as there are small branches already filling in the open areas of the tree canopy. Using a liquid nutrient four to five times a year will increase the growth speed of the entire tree and the branches filling in the open areas of the canopy.

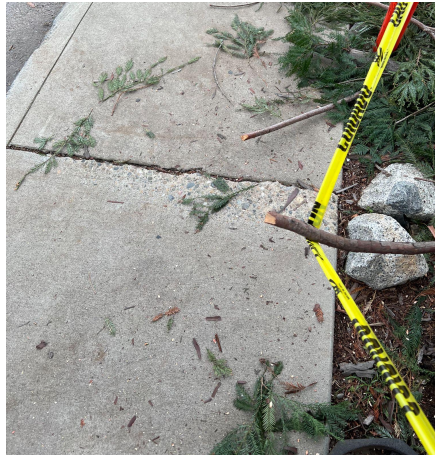
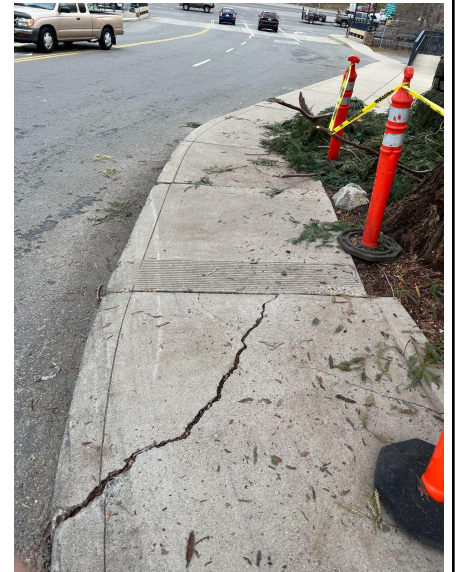
There is an approximately 1 inch crack, crossing the sidewalk around the tree, from the side to the center up to the expansion joint.
The sidewalk has also been ground down in the past to reduce the trip/fall risk.

The damage to the sidewalk was caused by soil expansion from tree root pressure as the roots grow and expand below the sidewalk. The sidewalk directly below the tree could continue to be repaired, or be replaced with a more easily repairable walkway system. The holiday lights attached to and wrapped around branches could have caused some of the branches to fail with the additional pressure from the lighting components. The electrical box and conduit that are attached to the tree were damaged by the recent branch failures.

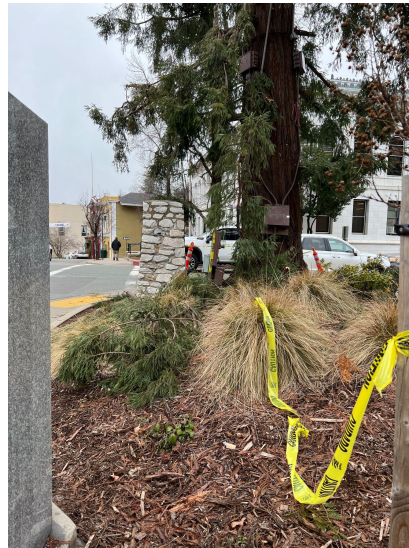
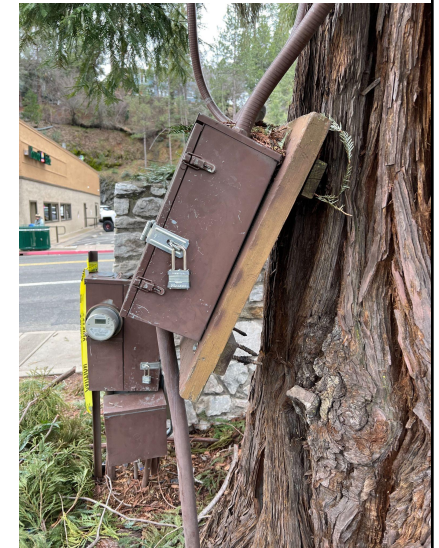
There is an electrical lighting box and associated conduit for holiday lights affixed to the tree's trunk, as well as, a permanent star ornament located on the top of the tree.
The tree is also being used as a support for irrigation components.

1. Do nothing and continue to manage the tree in the same manner as the past.
2. Remove the tree.
3. Remove broken branches. Remove holiday lighting, and other infrastructure from off of the tree.
Treat the tree with a tree growth regulator, Paclobutrazol (Shortstop) every 2-3 years.
Treat the tree at least 4 times a year with 5-10-10 liquid fertilizer (GES 5-10-10).
Treat the tree at least 2 times a year with di-potassium salts of phosphates (Reliant).
Installing a permanent holiday lighting system that does not negatively impact the tree could be considered.

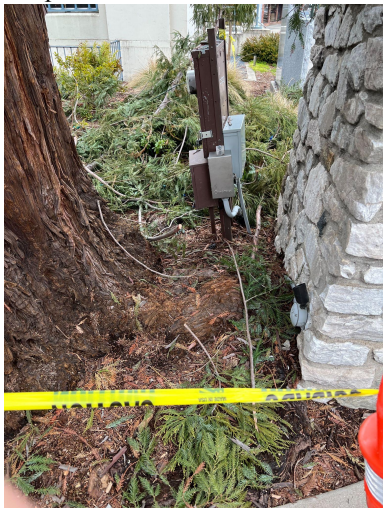
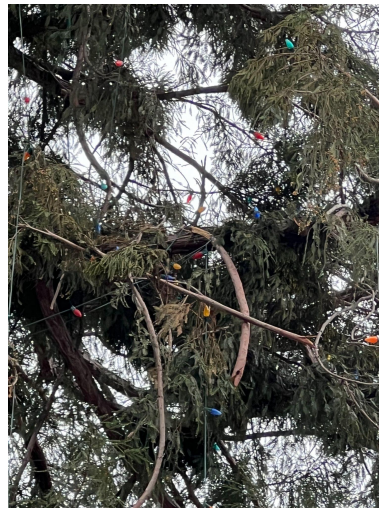
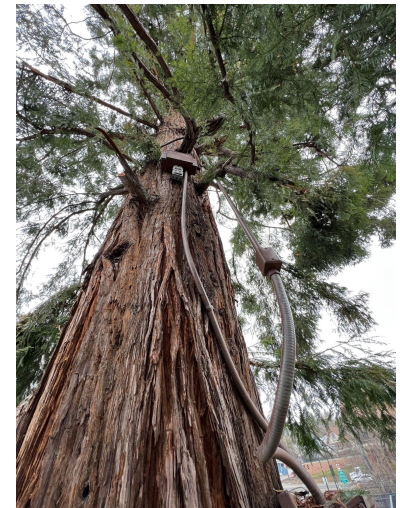
During the 2023 winter storms, branches began falling under the weight of snow. In photo 2, it is clearly seen that the holiday lights are tied up with fallen tree branches.

In late 2022, powerful winter storms with snowfall at lower elevations hit our area and began causing damage to the tree, which continued into the spring of 2023. During these storm events, some of the redwood tree branches fell onto the sidewalk and landscape plants, but caused little damage to the landscape and no injuries to pedestrians. The branch failures created a large, and rather unsightly, gap in the living tree canopy, mostly on the west side of the tree.
