Placerville Old City Hall Stabilization Structural Investigation

Placerville, California

June 30, 2023

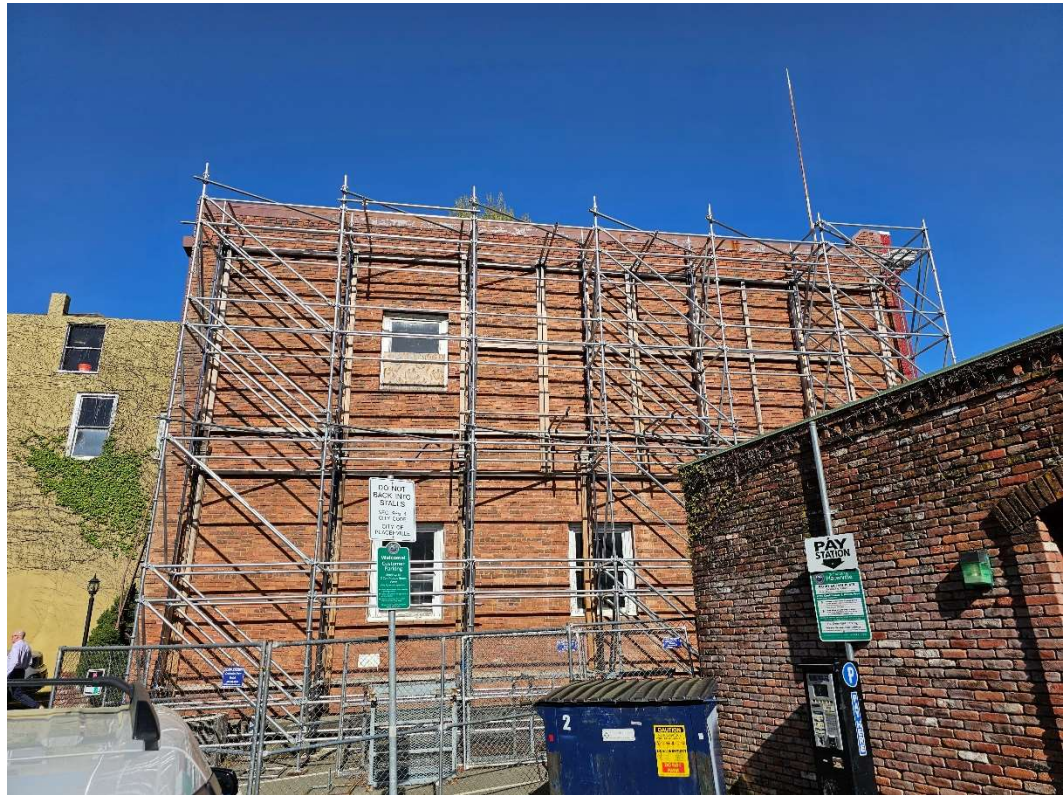
Exterior bearing walls consist of brick wall at the west wall, brick and rock at the east wall, brick at the south wall, and concrete and wood at the addition portion. All walls appear to be load bearing at exterior and interior. The west wall observed about four to six inches of out of plane deflection and bowing at the center of the wall at the upper level.

Photo #5: West Elevation

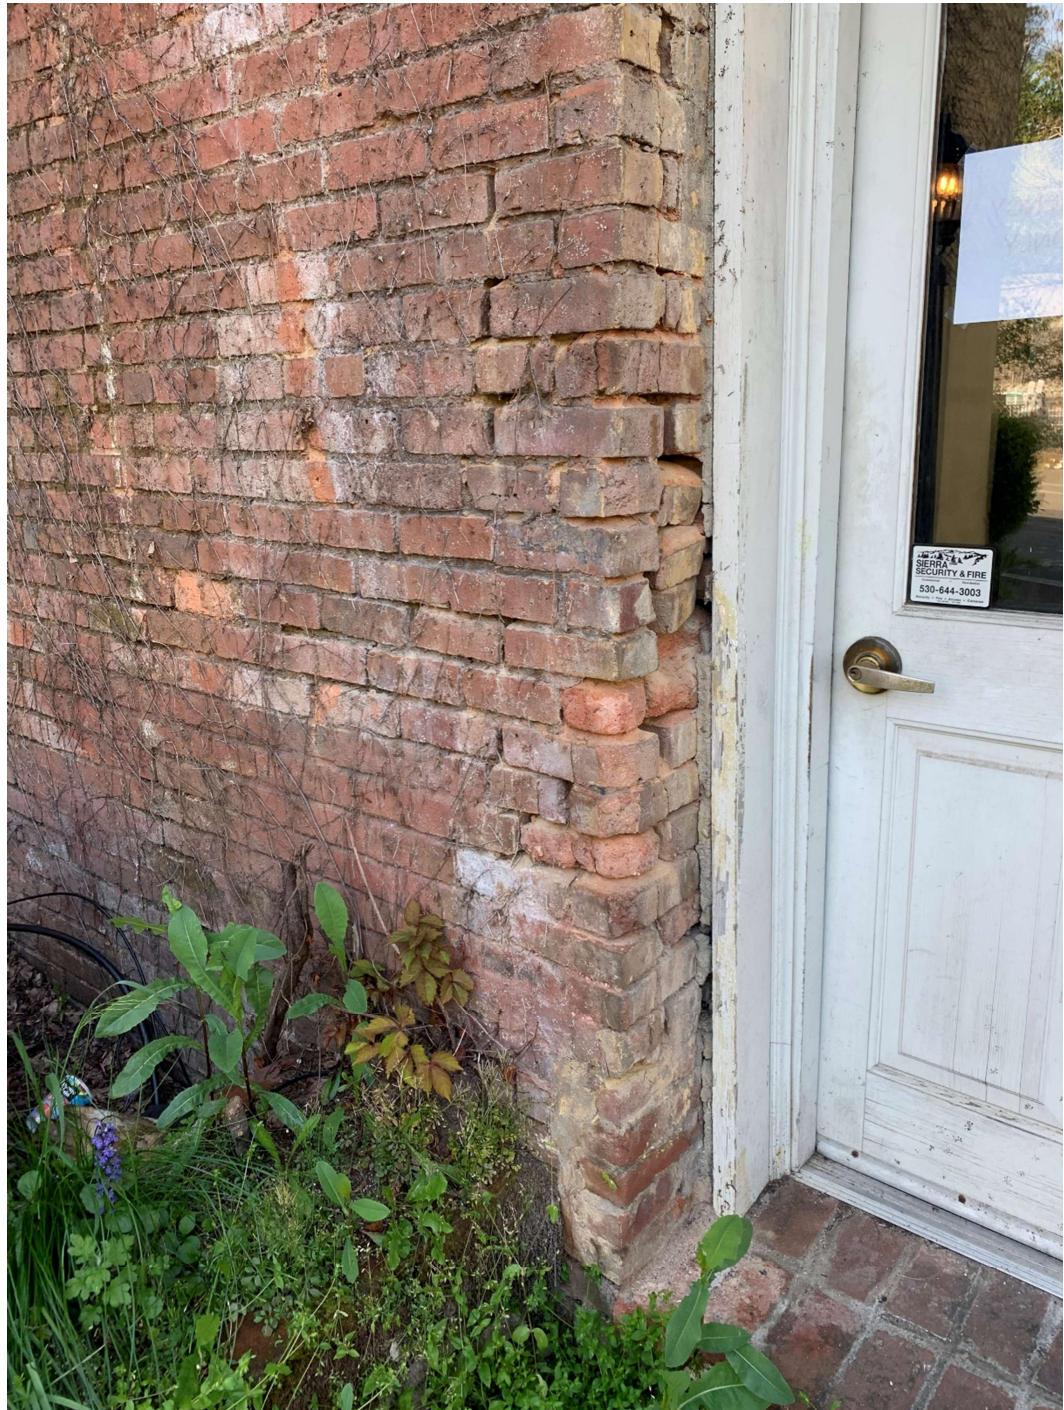
1. We observed damage to the brick wall in areas on the north side of the west building near the ground level. Some bricks were removed at the door jamb revealing the deteriorated condition of the mortar matrix. The mortar appeared to be dry and granular as was draining out of the space between brick from gravity. The lime in the mortar that provides the bonding capability had likely leached out over time. Typical mortar joint at exterior was soft and easily removed, see Photo 9. None of the brick

faces appeared to be deteriorated however there was no evidence of re-pointing.

Photo #9: Brick damage near door jamb at Confidence Hall building

1. Localized brick damage should be encapsulated by filling with a Type O mortar and forming face to prevent additional mortar from being displaced until permanent repairs can be made.

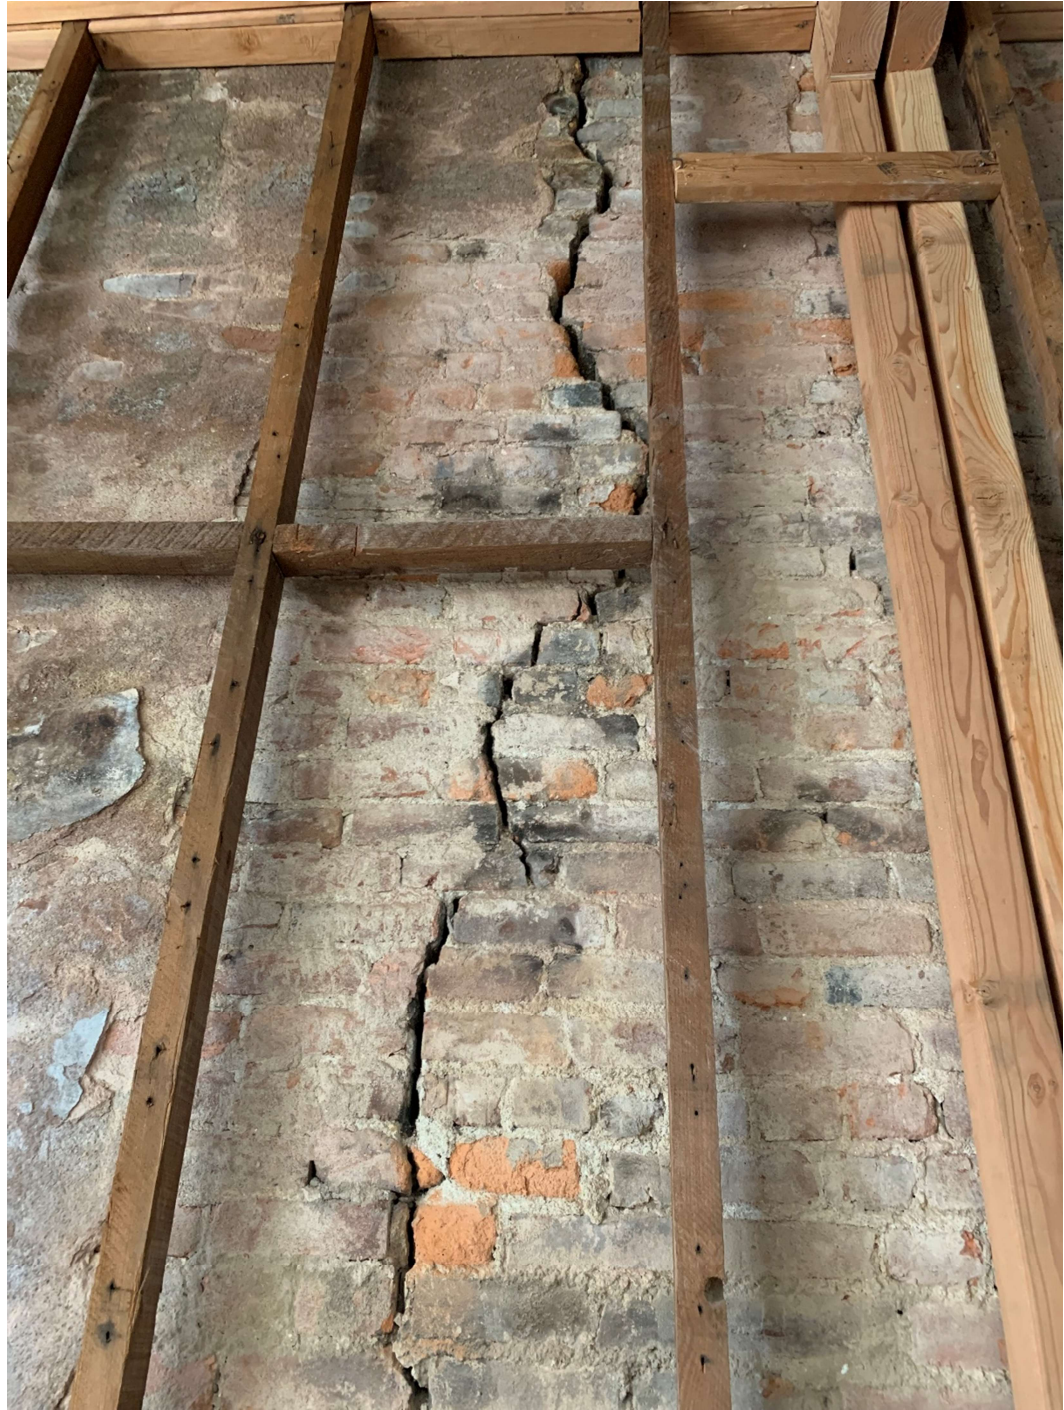
Photo #10: Crack in brick wall (West wall end)

2. The reason for the wall cracks at the west wall of the Confidence Engine Company Hall building is likely due to an inadequate wall anchorage system to tie the wall to the floor and roof level. Fire damage occurred previously near the wall and not all of the wall anchors were replaced which caused the wall to displace from the floor levels. There were a few existing wall anchors towards the north and south wall ends but not near the center of the wall where the crack in the wall was the largest. The shoring system provides temporary out of plane wall bracing however, continuous anchor ties will need to be established around the building to tie the exterior walls at the floor and roof levels. Where there are existing wall ties installed per the shoring design drawings, additional Simpson HDU's are proposed to be installed at the opposite end of joist. The

HDU's will have a threaded rod that will span across the Emigrant Jane building and tie the West wall to the rest of the building, see SSK-1 and SSK-2 for details.

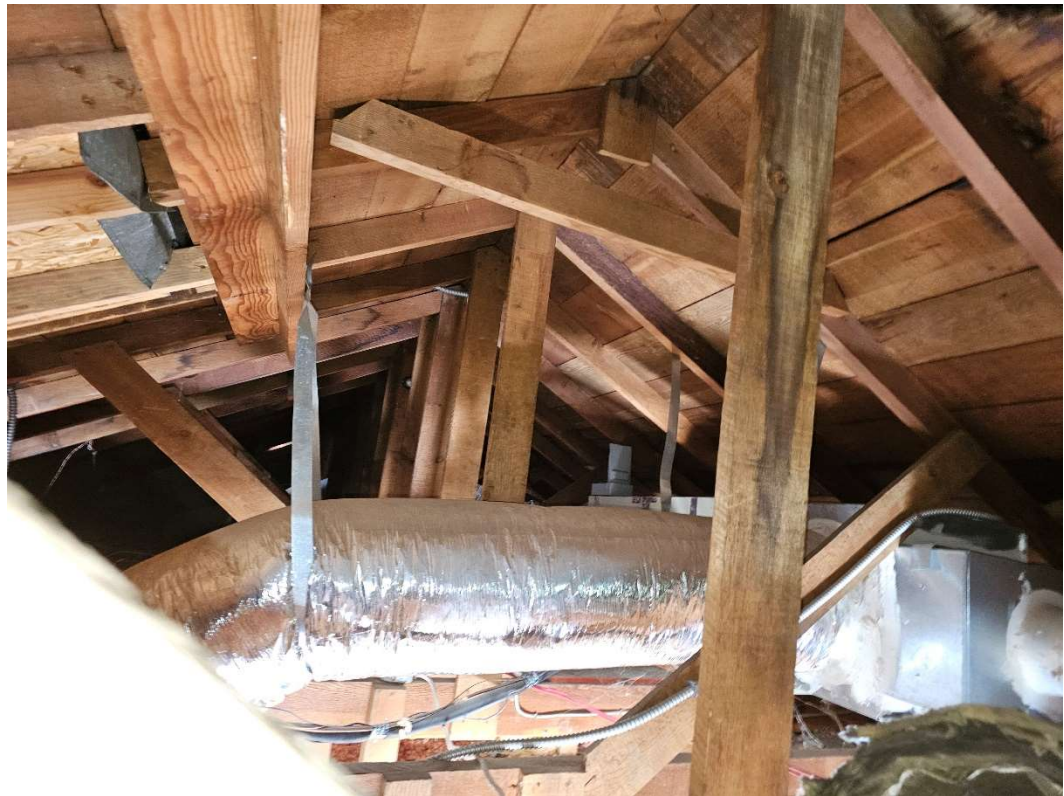
3. We observed roof framing of the Confidence Hall building at the interior wall. The truss chords were pocketed into the brick. We did not note any lateral movement of the chord in the wall pockets that should have been evident in the ceiling finishes at that intersection.

Photo #11: Company Hall Building Roof Trusses

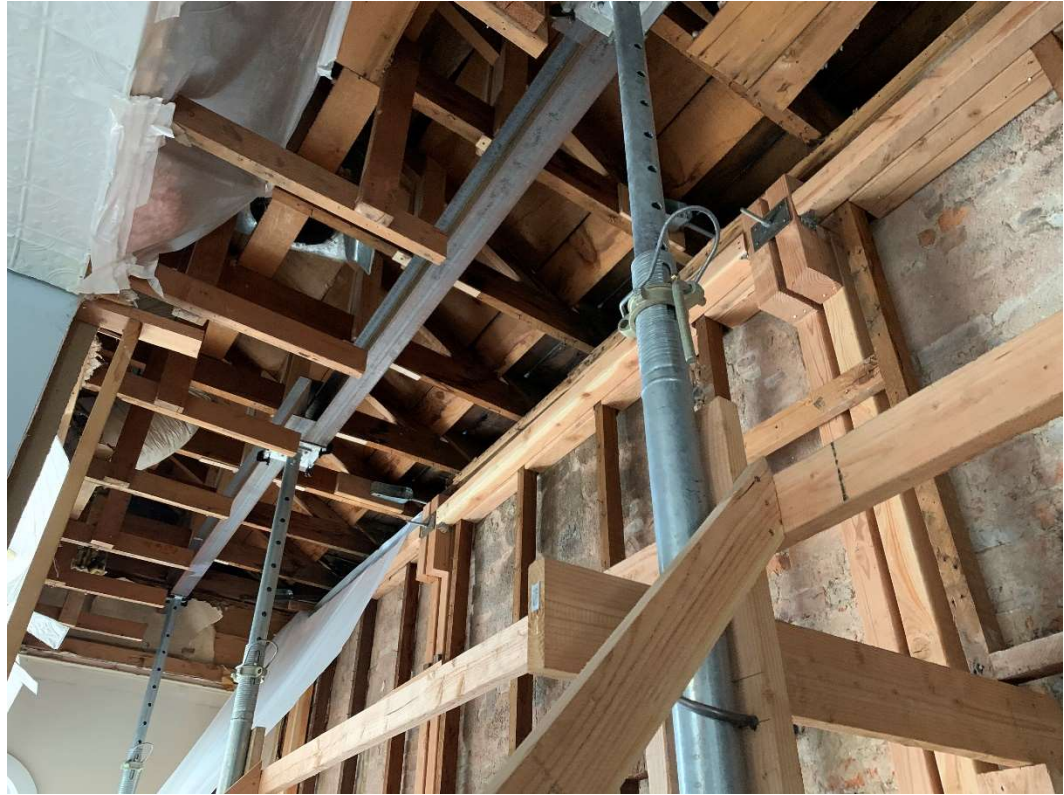
Photo #12: Company Hall Building Roof Trusses bearing on existing furring stud

3. The roof framing at the Confidence Hall building is currently supporting on a 2x3 furring stud wall. The roof trusses initially were supported by a five-inch step in the brick wall but due to the out of plane distortion of the wall, the furring stud wall is now the main support. In order to tie the roof to the rest of the building, a similar mechanism to the second floor for stabilization of the wall is proposed. A new HDU will be installed at the opposite end of the truss bottom chord with a threaded rod that spans across the Emigrant Jane building to the East wall end, see SSK-3 for details. At the North and South wall ends, the existing wall ties do not appear to be connected to the roof framing. To reestablish the wall ties at these walls, where there is an existing wall tie, a new angle brace that is thru bolted to the exterior brick wall and bolted to the top truss chord with blocking is proposed. Blocking and straps will be added to tie the walls to the roof diaphragm see SSK-4 for details.

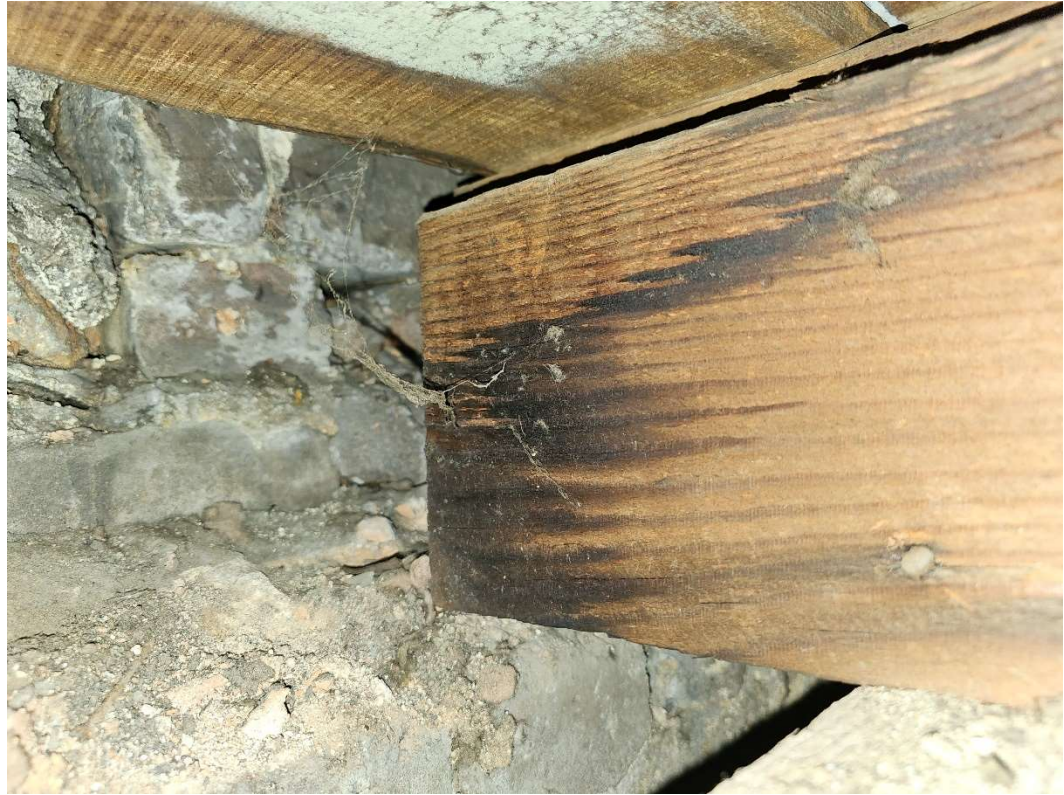
2. The Confidence Engine Hall building had evidence of fire damage to the roof and floor structure. Some smoke discoloration was on the inside face of brick along with charred pieces of wood frame attached to the brick, see Photo 13. Anchor ties from the brick intended to engage floor and roof framing were left in place loose in the re-construction. We observed the roof trusses to be supported by the furred wood wall and not pocketed into the brick wall as was the likely the original construction. The west wall at roof level is currently not bearing and was not supported laterally to the structure.

Photo #13: Company Hall Building Roof Trusses West wall support displacement

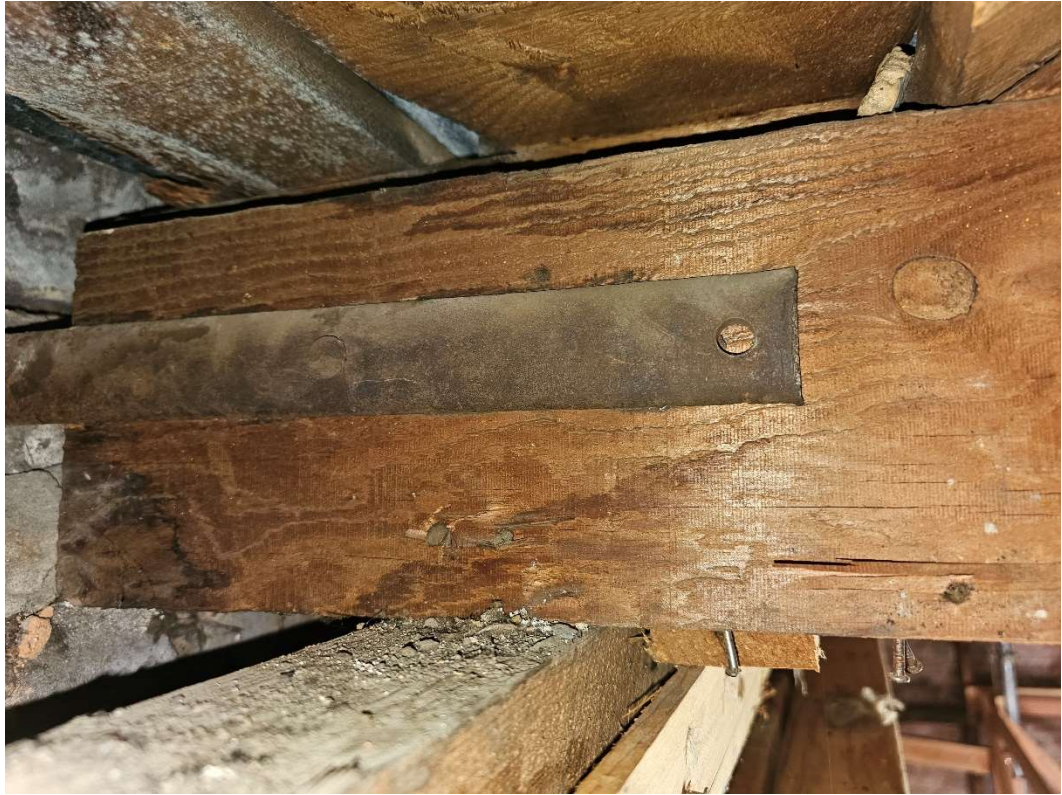
Photo #14: Roof truss wall anchor (Confidence Engine Company Hall)

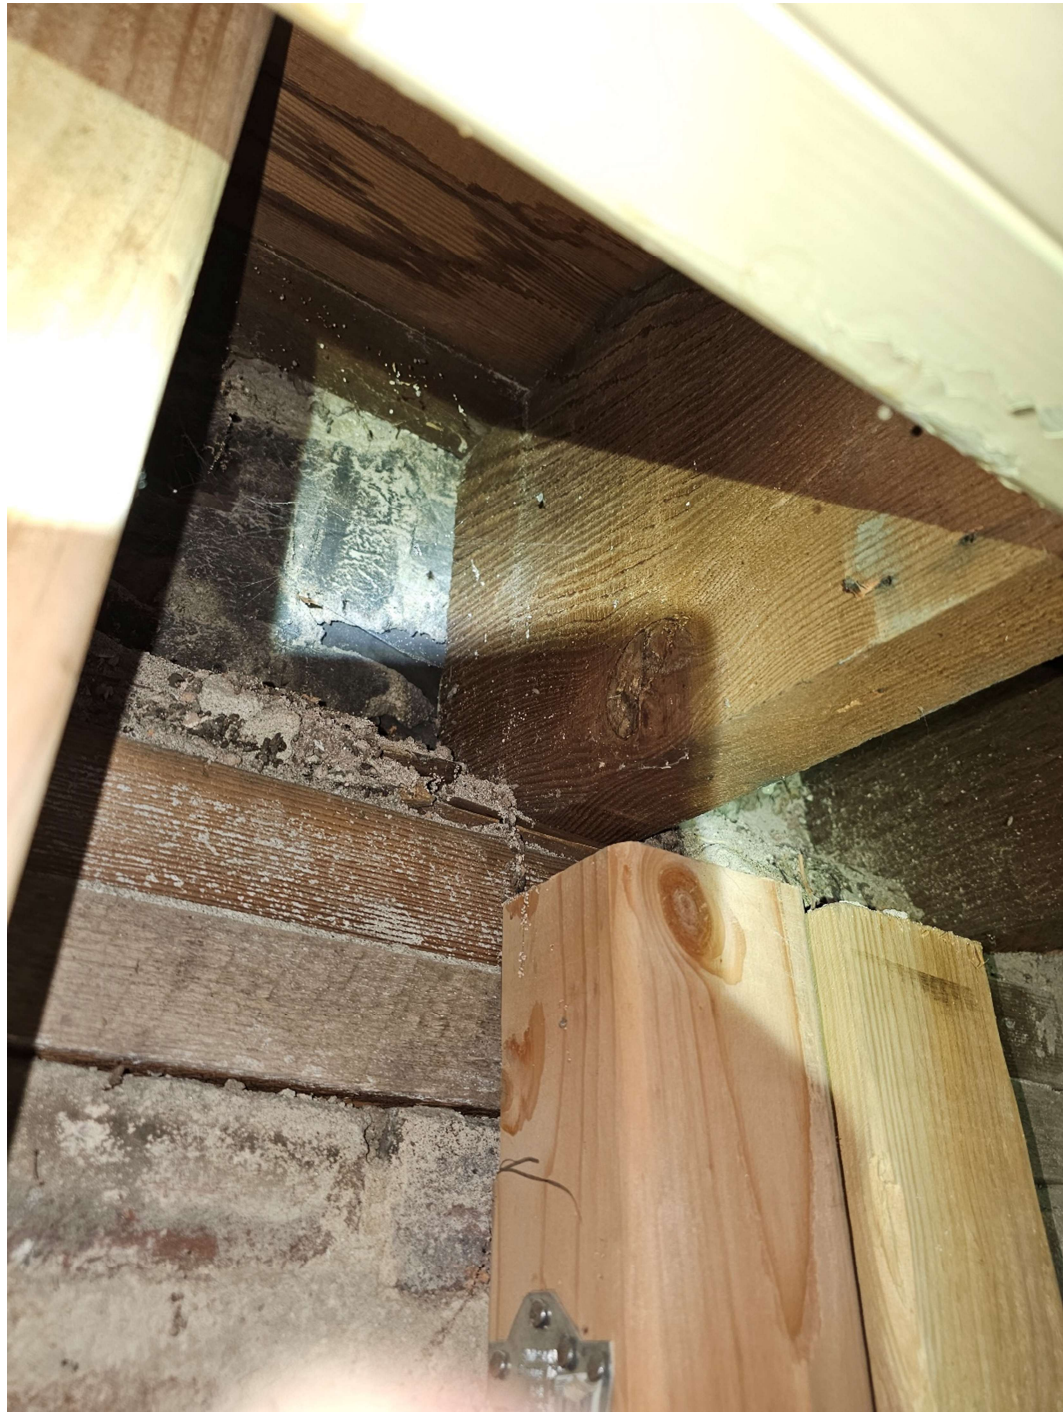
Photo #15: Company Hall Building 2nd Floor West wall support

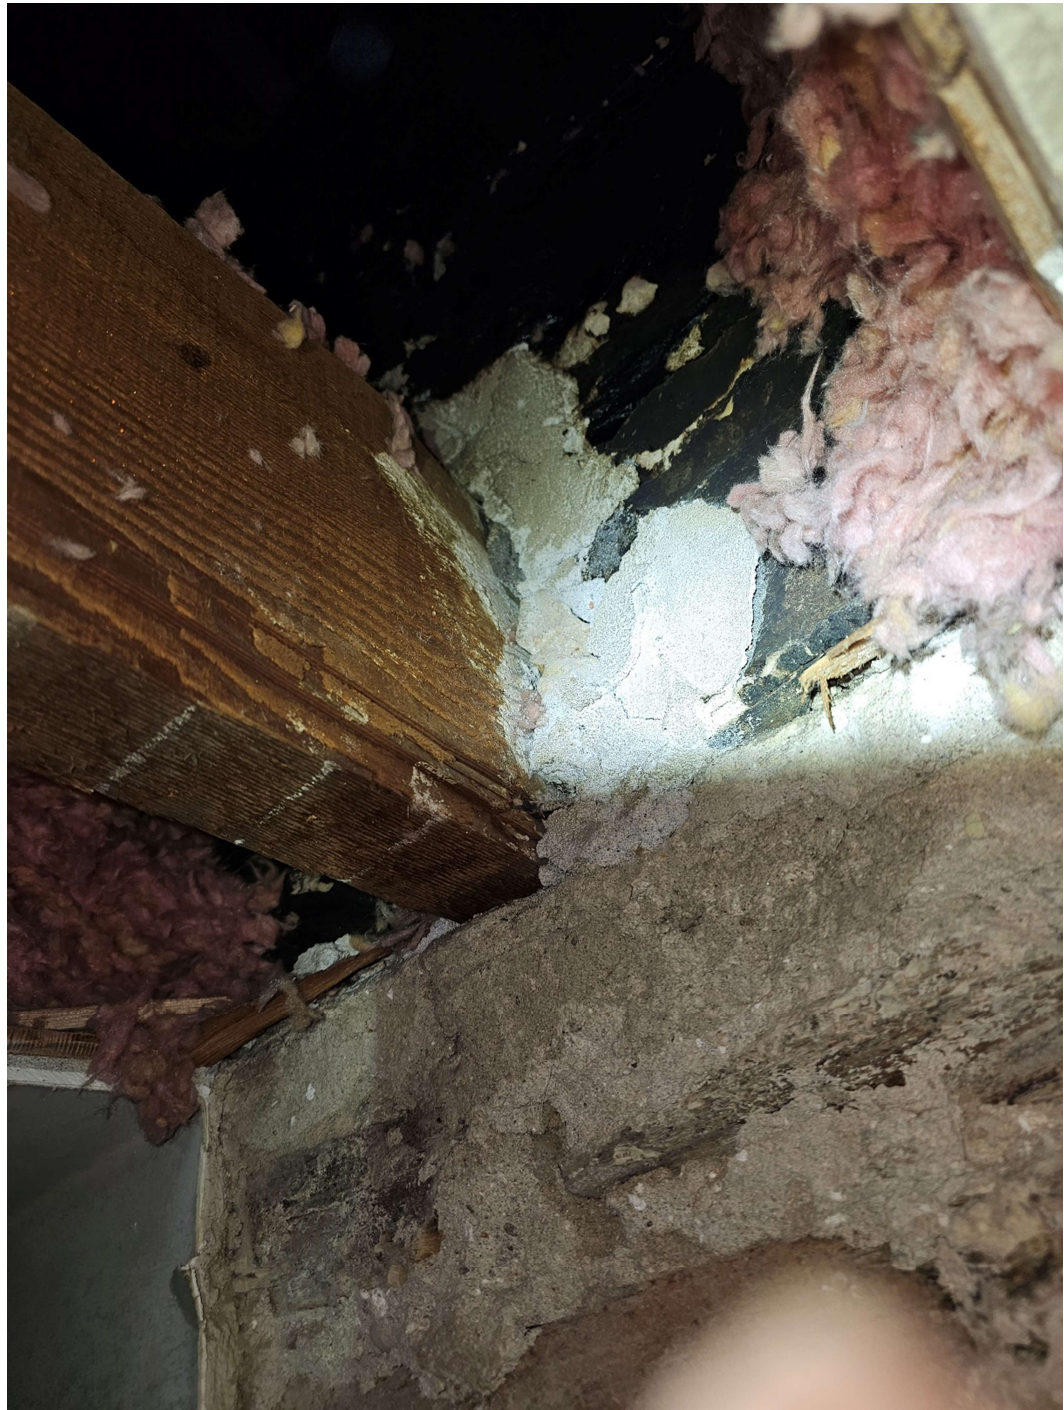
4. The stone masonry walls on the Emigrant Jane Building appeared to terminate at a "parapet" distance above the second floor and continue with brick above. This leads us to question the order in which the buildings were constructed and if the first structure was originally a single-story building with a basement.

Photo #16: 2nd Floor Interior Rock (below 2nd) to Brick (above 2nd) Transition

4. The rock mortar matrix of the walls appears to be intact. No repair is recommended for this stabilization phase. This will be addressed in future retrofit phase.
