June 6, 2022

Mark Liebenow
Facility Superintendent
Hangtown Creek Water Reclamation Facility
2300 Coolwater Creek Rd
Placerville, CA 95667

SUBJECT: Structural Observation of Existing Building

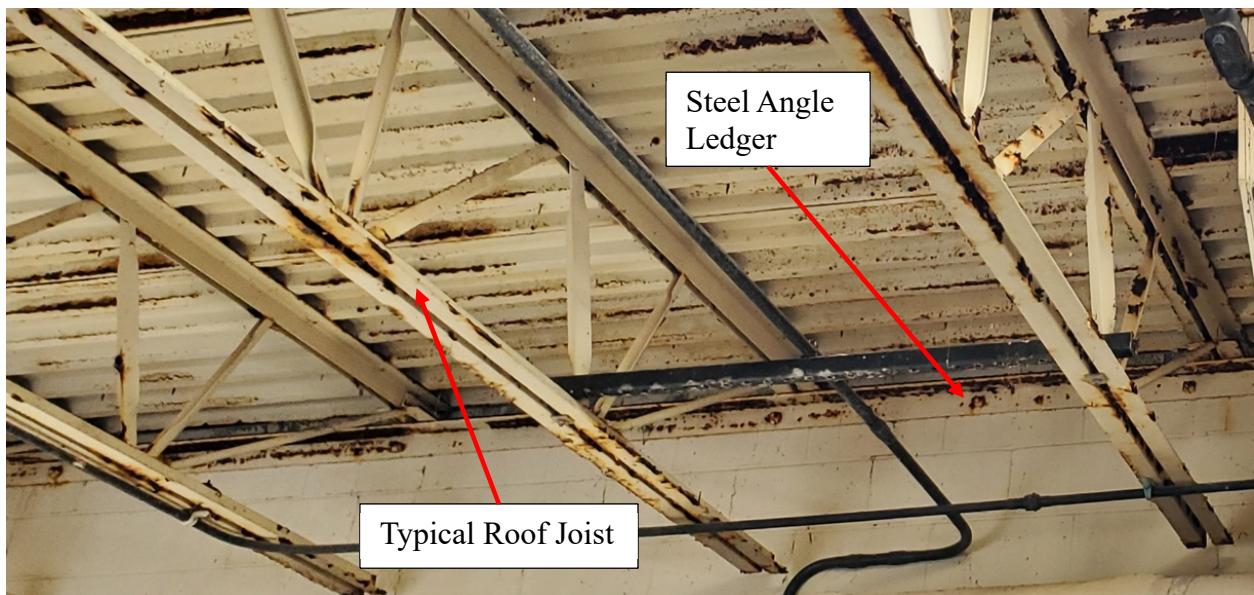
Figure 3 – Roof Joists Bearing Perpendicular to the Wall

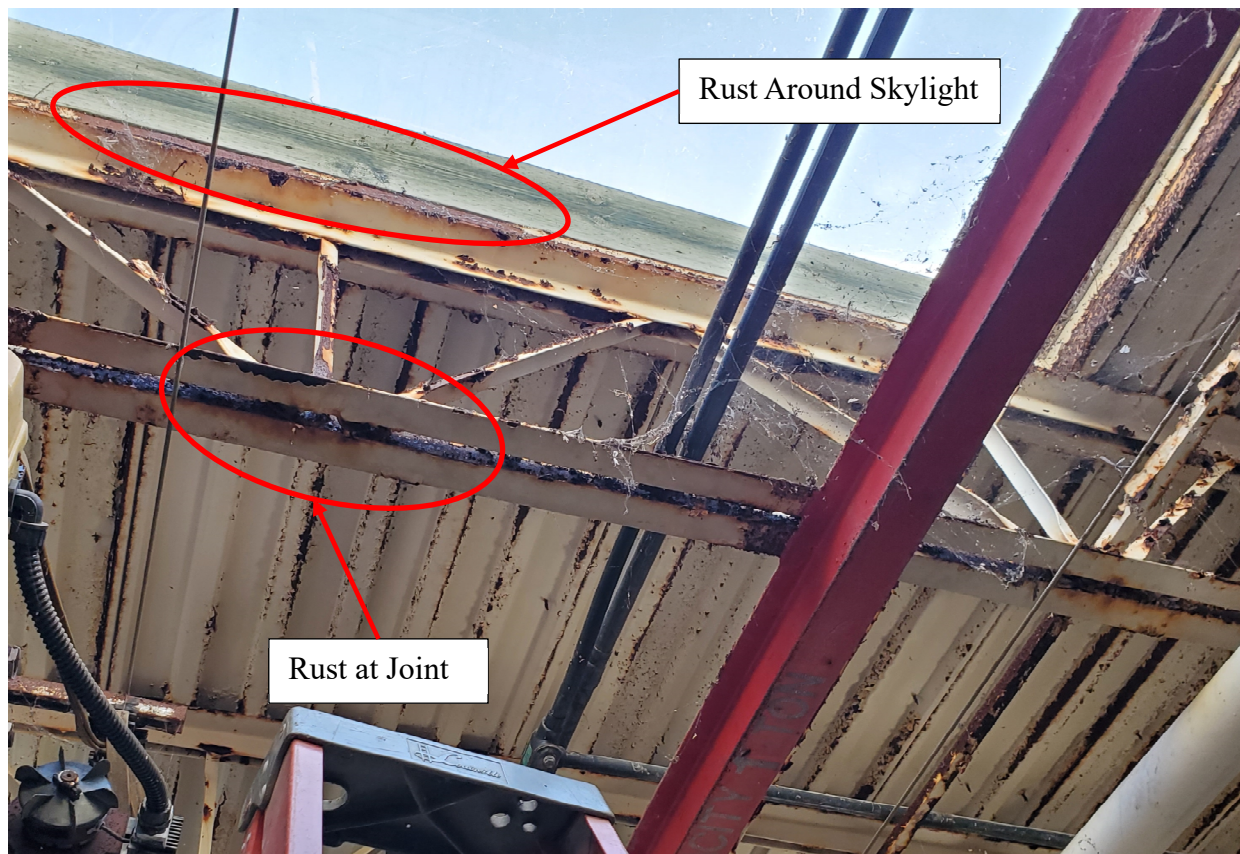
Throughout the roof structure, there is evidence of paint spalling and rust/corrosion on the joists, braces, and steel angle ledgers. Some of the more severe cases of rust are located at joints on the joists, near the skylights (see Figure 4), around the access hatch (see Figures 5 and 6), and at the ledger connection to the wall (see Figure 7). At a few joints on the open web steel joists, near the middle of the span, we observed a loss of section on the joist bottom chord on the order of 1/32" (more than 10% section loss). Near the access hatch, parts of the top chord appear to have lost most of its section. These areas appear to be severely damaged and should be retrofitted or replaced as soon as possible. Considering the extent of the damage to the joists and the connections to the wall, we recommend replacement of the entire roof structure.

Figure 4 – Roof Joists Near Skylight

It is our understanding that the rust/corrosion is a result of the water treatment process generating high levels of ammonia and that the current/future process will not generate ammonia or any similar corrosive substances. A contributing factor to the corrosion may be the potential water intrusion around openings in the roof. Considering this change in process and the planned replacement of the roof deck, we recommend that the roof be replaced in kind with open web steel joists connected to the CMU walls with new steel angle ledgers. Some of the embedded anchors may need to be replaced with new post-installed anchors.

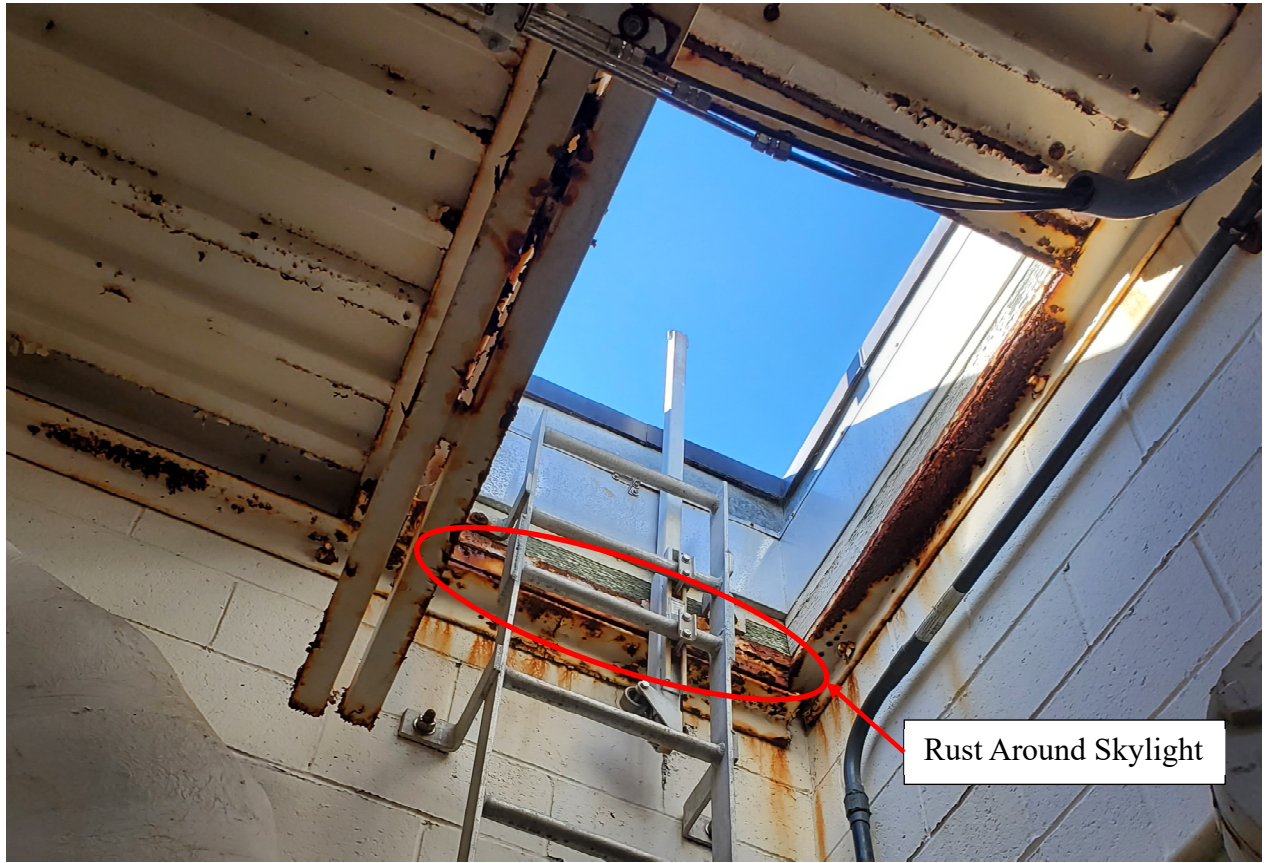
Figure 5 – Roof Joists at Access Hatch

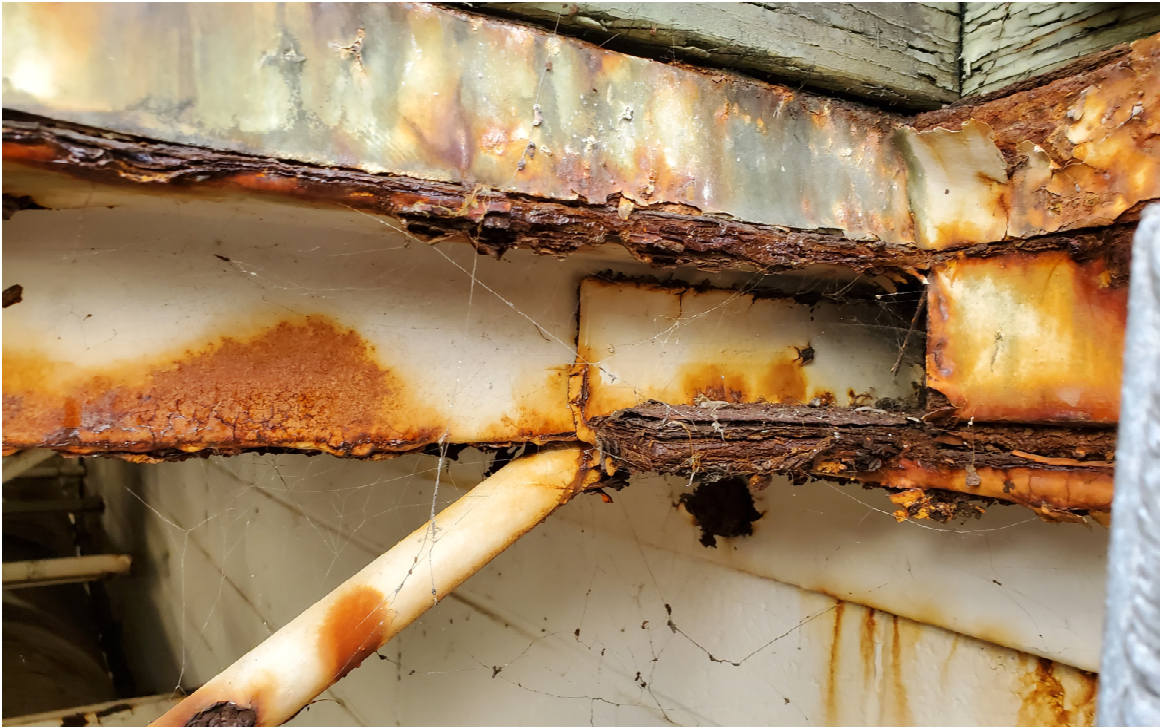
Figure 6 – Roof Joists at Access Hatch

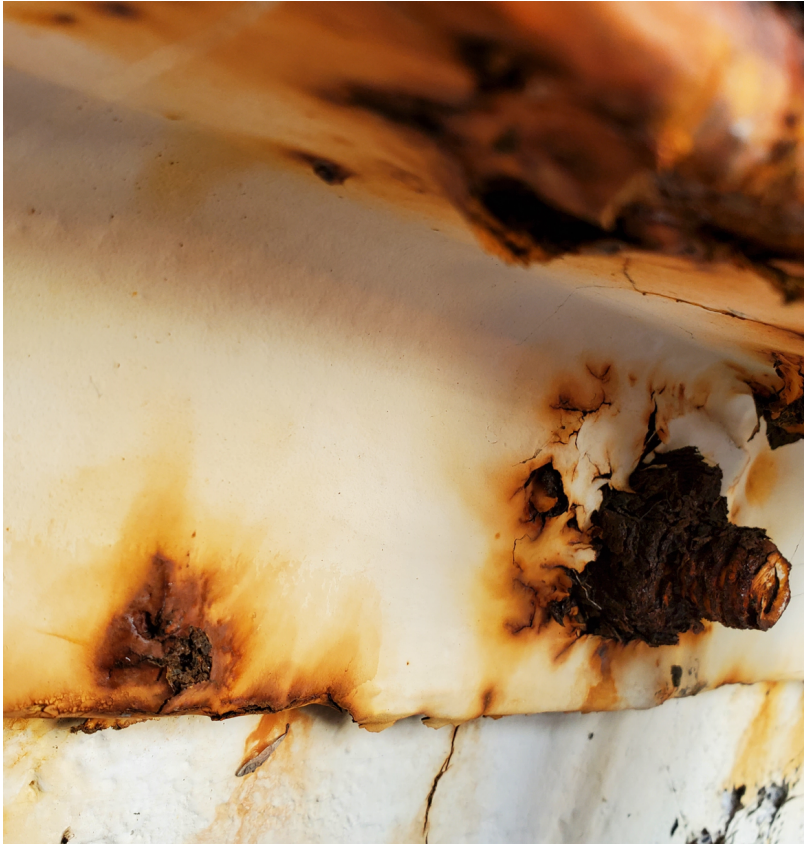
Figure 6 – Steel Angle Ledger at Wall
