# **HISTORIC CITY HALL REUSE REQUEST FOR PROPOSALS**

## **REQUEST FOR PROPOSALS FOR REUSE OF CITY PROPERTY LOCATED AT 487/489 MAIN STREET, PLACERVILLE, CALIFORNIA**

# Feasibility Study for the Rehabilitation of Old City Hall Building 487-489 Main Street, Placerville

Prepared by:  
**Burne Engineering Services, Inc.**

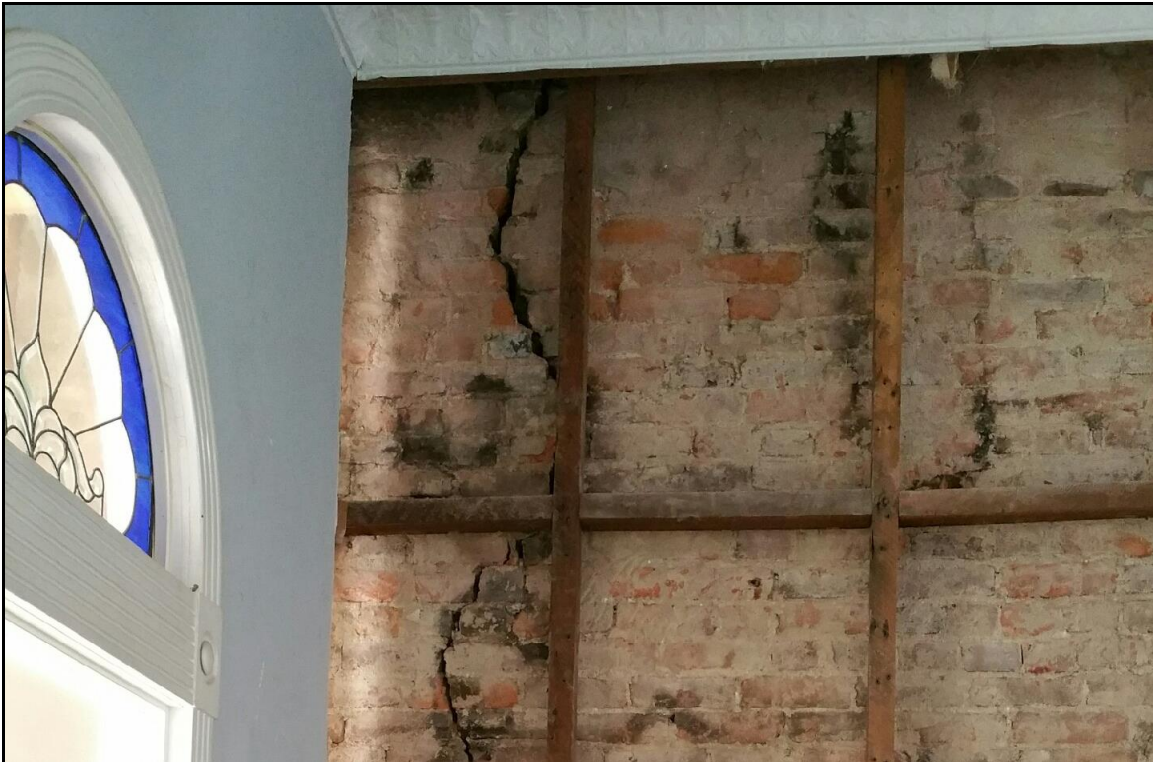
- Cracks in the masonry walls [Figure 1]
- Deterioration of mortar joints in masonry (brick or stone) walls [Figure 2]

*Figure 1: Large cracks in the west masonry wall.*

- A** RE-POINT (E) EXTERIOR WEST AND SOUTH WALLS OF CONFIDENCE BUILDING FROM BOTH SIDES OF THE WALL. INFILL / RECONSTRUCT VOIDS IN WEST WALL AT FIREPLACE CHIMNEY. POINTING SHALL BE DONE IN ACCORDANCE WITH UNIFORM BUILDING CODE STANDARD 21-8. SEE "OPTION 1: URM RETROFIT STRATEGY" SHEET.
- B** RE-POINT OTHER WALLS & FOUNDATION AS REQ'D PER RESULTS OF TESTING.
- C** BRACE PORTIONS OF (E) ROOF PARAPET EXCEEDING 16" ABOVE TOP OF ROOF FRAMING. RE-POINT / REPLACE / REMOVE PORTIONS OF PARAPET AS REQUIRED.
- D** REMOVE ROOF COVERING, PROVIDE NEW ROOF SHEATHING AND CORRECT ROOF DRAINAGE SYSTEM PRIOR TO PLACEMENT OF NEW ROOF COVERING.
- E** ADD NEW PLYWOOD OVER (E) FLOOR SYSTEMS TO STRENGTHEN FLOOR DIAPHRAGMS.

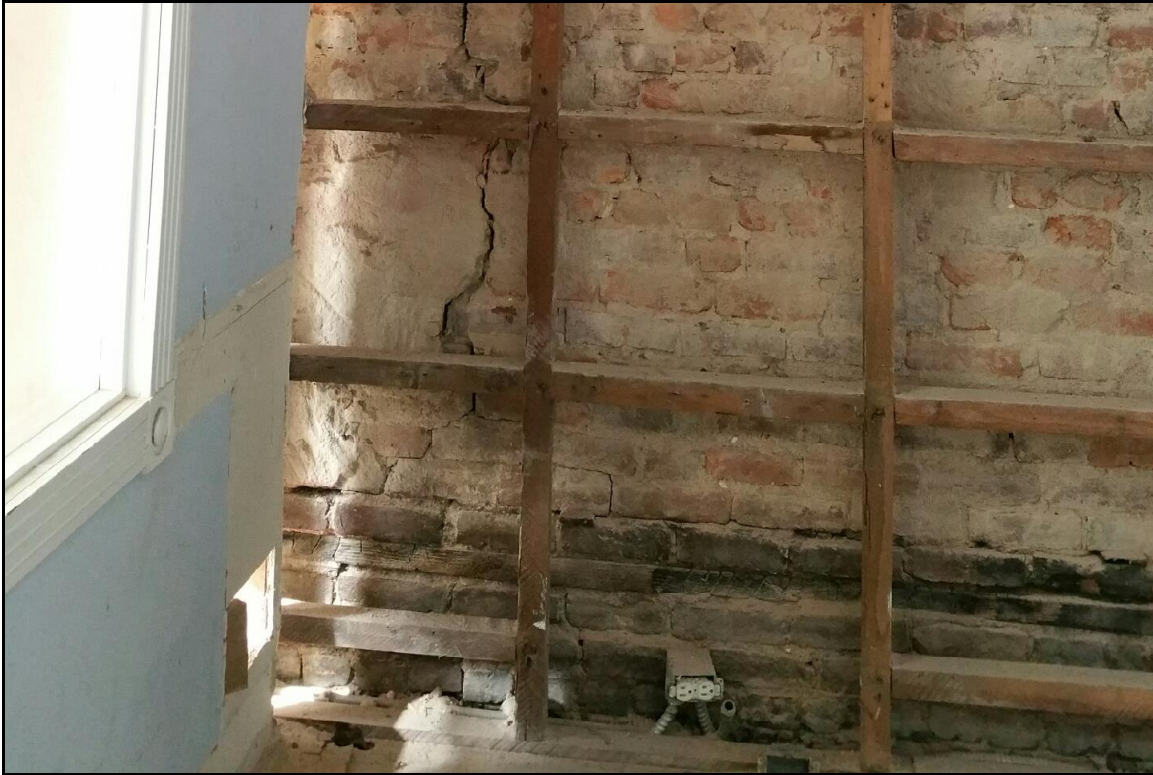
*Figure 2: Deteriorated bed and head joints in masonry walls.*

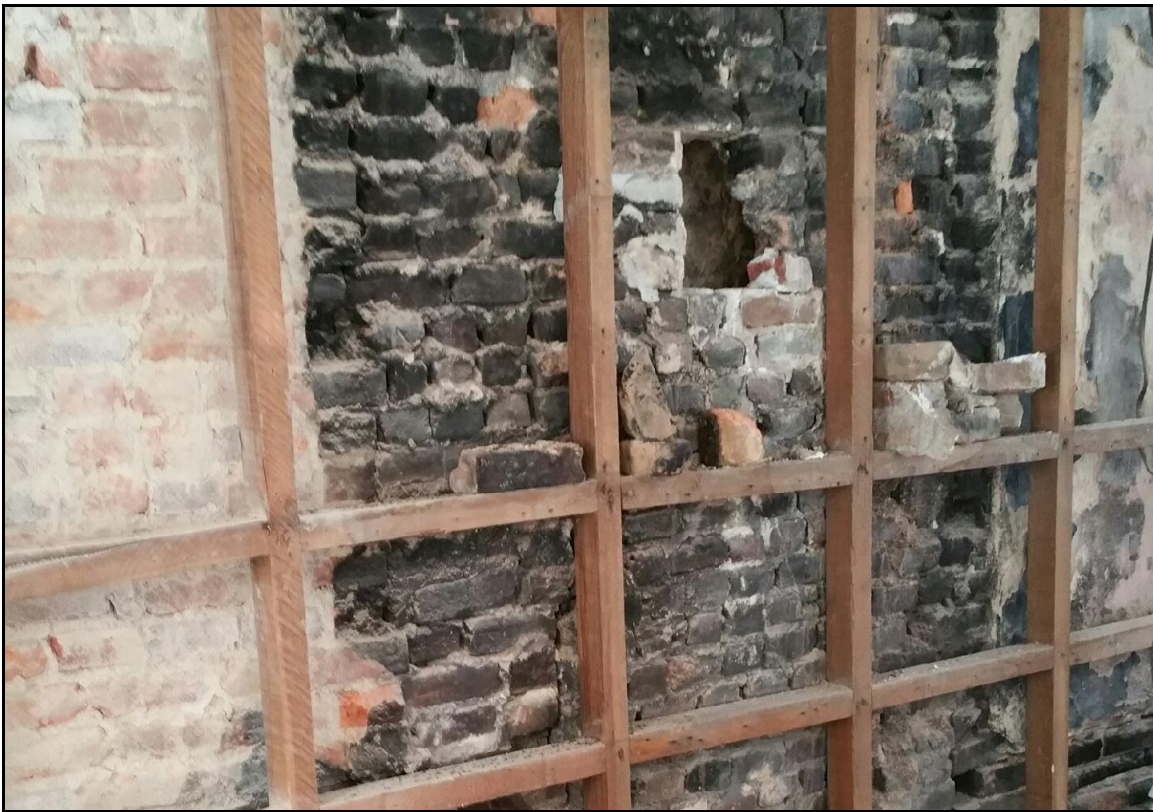
- Fire damage in the wood bed joints inset in the masonry walls [Figure 3]
- Collapsed chimney chute, voids in wall [Figure 3]
- Non-integrated closures at existing openings, lintel reconstruction needed [Figure 4]
- Lack of positive connection between walls and floor/roof diaphragms
- Walls pulling away from the floor/roof (up to 6" on the West wall) and bowing
- Unbraced parapets [Figure 5]
- Seismically inadequate floor and roof diaphragms

*Figure 3: Voids in wall at chimney area. Fire damage to inset timbers.*

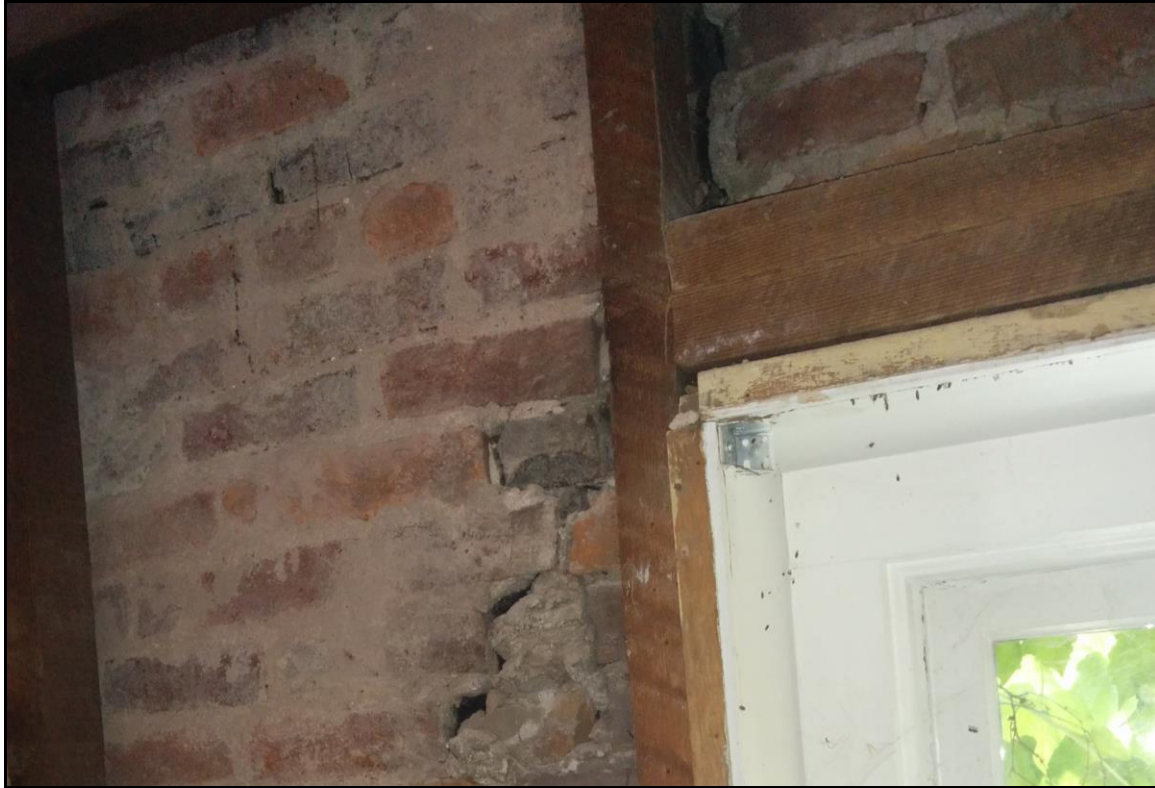
*Figure 4: Door opening not integrated with lintel. Lintel to be reconstructed.*

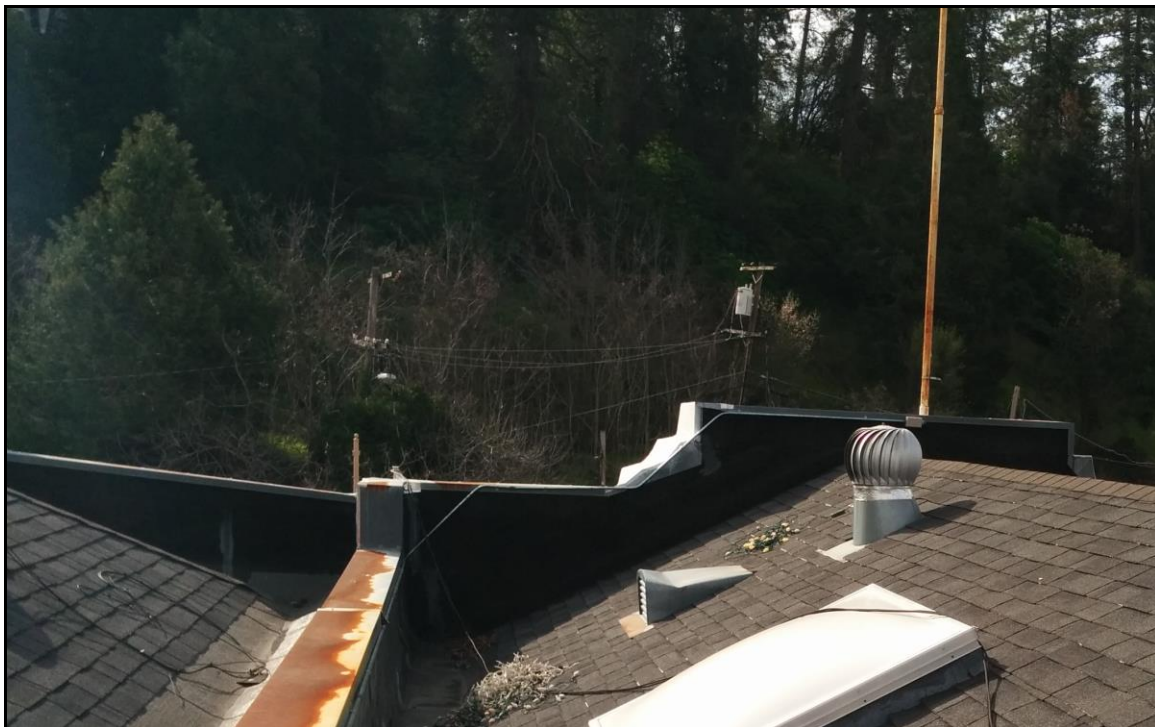
*Figure 5: Unbraced roof parapet*

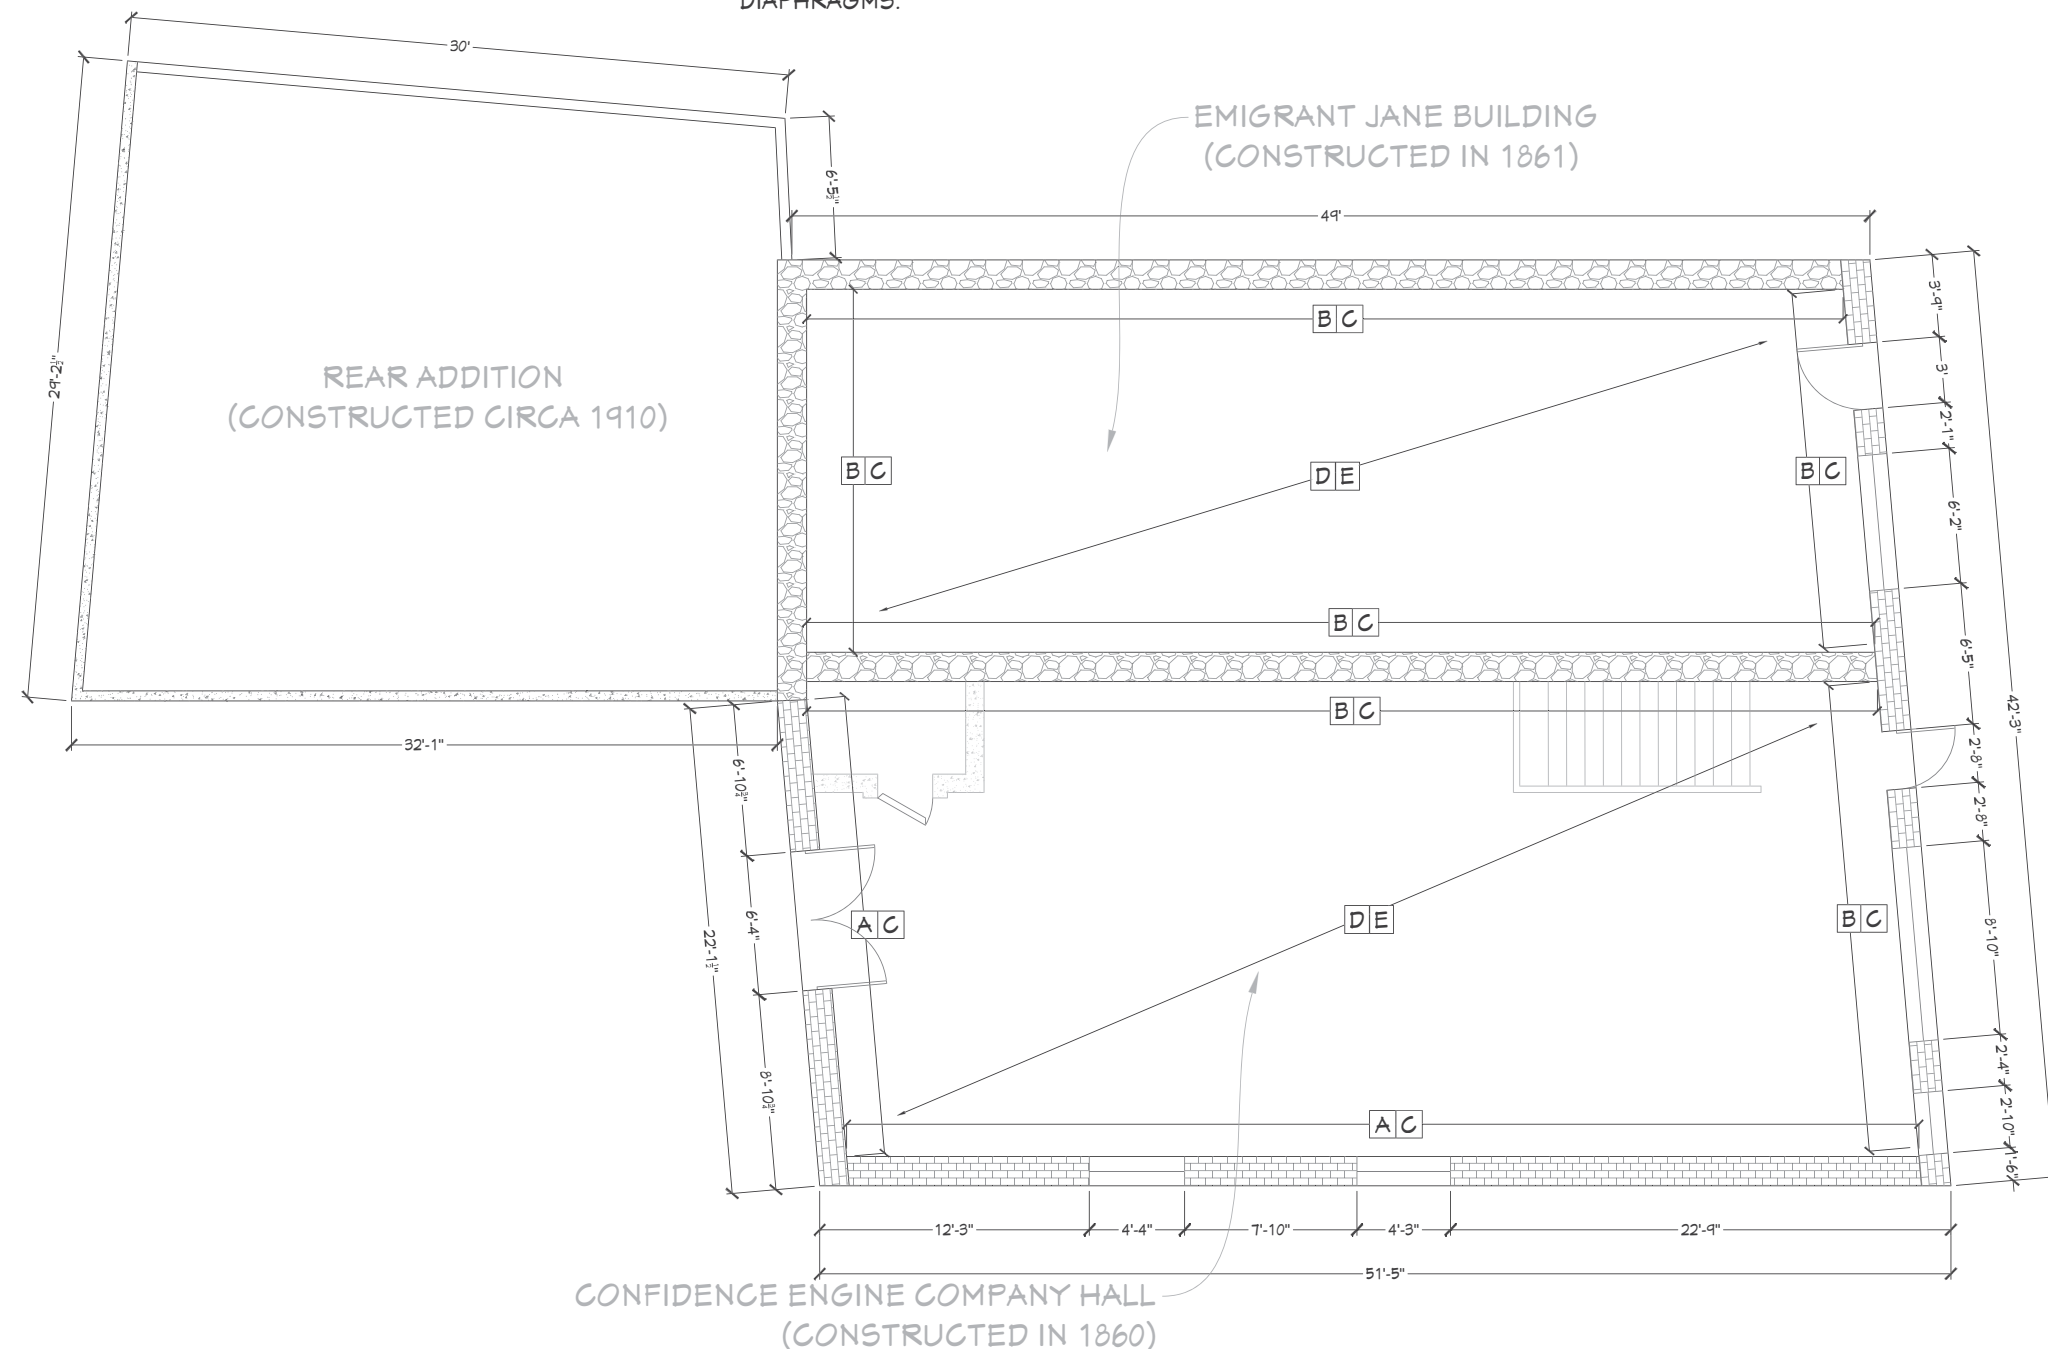
COMMON MEASURES FOR ALL THREE OPTIONS  
OLD CITY HALL BUILDING  
487-489 MAIN STREET  
PLACERVILLE, CA 95667

Independently of which of the three lateral force resisting system alternatives is chosen, there are some critical structural issues that will need to be addressed in all scenarios. The cracked and deteriorated portions of the masonry walls will need to be repointed and the cracked bricks will need to be replaced. The chimney chute in the west wall of the Confidence building will need to be filled with new masonry. The roof parapet will need to be braced and/or shortened. The floor and roof diaphragms will need to be sheathed on top of the existing sheathing. Additionally, the roof and floors will need to be anchored to the new or existing framing. All of the exterior landings and stairs may need to be removed and those required for exiting will need to be replaced with new code compliant exits. To simplify the graphical representation of each alternative, these common measures are shown as Sheet R0 and are applicable to all three options.
