Subject: Planning Commission Agenda Item Request - 2018 Reconnaissance Survey Downtown Placerville Historic District

**CULTURAL RESOURCES STUDY  
MAIN STREET COMMERCIAL DISTRICT  
PLACERVILLE, EL DORADO COUNTY  
CALIFORNIA**

September 2018

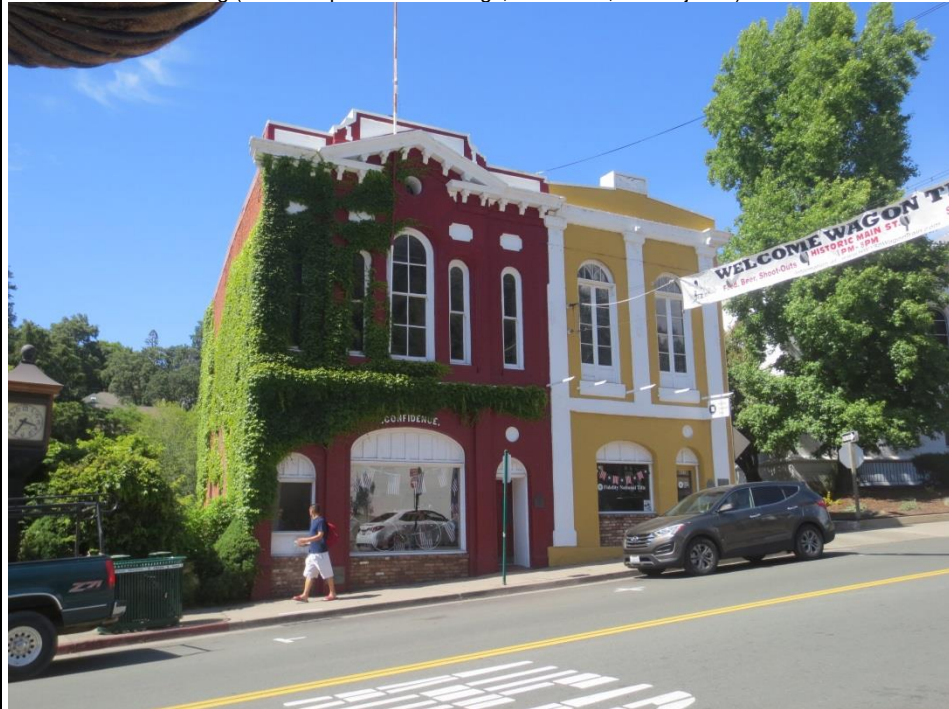
\*Resource Name or #: (Assigned by recorder) 487 Main Street

The Confidence Firehouse #1 is a two-story brick Italianate building erected in 1860. It has a gable roof with a stepped parapet. The primary first floor façade features a central wide arched window flanked by an arched window and arched pedestrian doorway; the central arch was originally the fire truck doorway, and was flanked by a window and pedestrian door. The lower portions of the central and westernmost arches have been blocked up with brick, while the upper portions of the arches have been filled with paneling. The upper story features five arched windows, a central tall 8/light double-hung window flanked by two narrow arched 2 light double-hung windows on either side. Lozenge shaped panels are located above each of the four smaller windows. A bulls-eye window pierces the upper gable, beneath a bracketed pedimented cornice. It is in excellent condition. The building was listed on the National Register of Historic Places, along with the Emigrant Jane Johnson House (489 Main Street).in 1982.

P5b. Description of Photo: (View, date, accession #) View North, June 2018  
Firehouse to left in photo

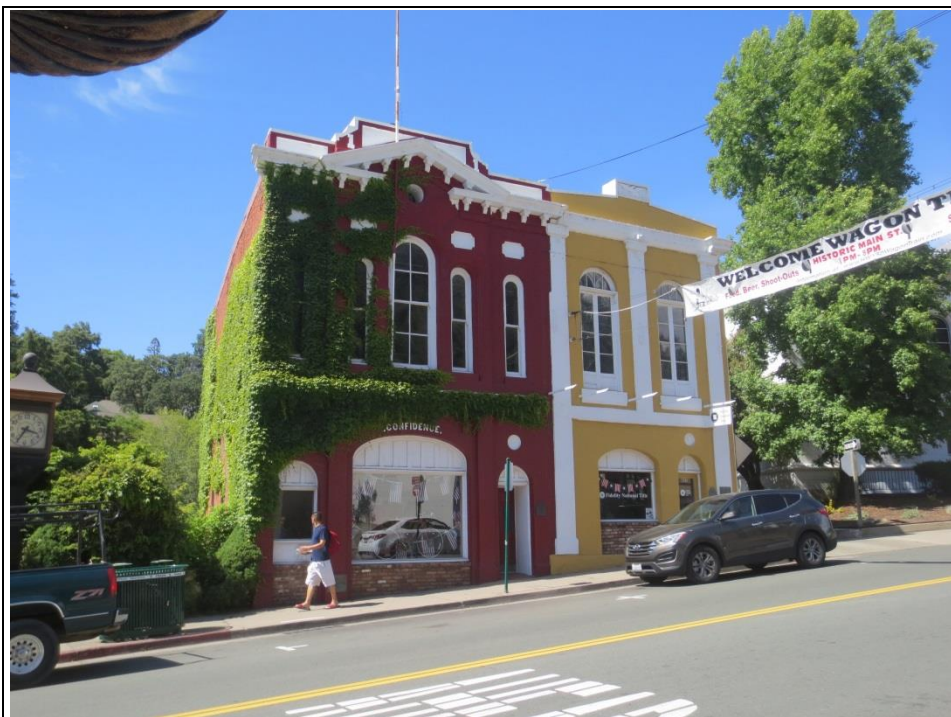
Built by Emigrant Jane Johnson in 1861, this is a two-story Vernacular Italianate brick building with a hip roof. The corners feature two-story Classical pilasters, while the upper story has a one-story central pilaster. A parapet on the primary façade features a rectangular pediment with J.S. and 1861 flanking an eagle. Fenestration on the upper story consists of two sets of arched French doors, each set with a multi-light transom and doors with four lights and a recessed panel. The doors originally provided access to a balcony which is no longer extant. The original first floor has been altered at least twice: once with storefront windows and now features a large arched storefront window and an arched pedestrian door; its original appearance is unknown. The building is in excellent condition. The building was listed on the National Register of Historic Places, along with the Confidence #1 Firehouse (487 Main Street) in 1982.

P5b. Description of Photo: (View, date, accession #) View North, June 2018  
Johnson House at right in photo
