LUMSDEN RANCH

ENVIRONMENTAL IMPACT REPORT **SCH No. 2007032130**

Volume 2: Appendices

**APPENDIX A:
NOP/INITIAL STUDY**

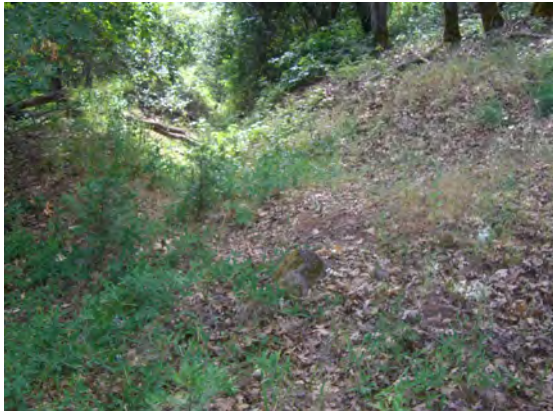
Figure 8. Main ditch blockage.

Remnants of the Main Ditch cross through the Lumsden Ranch property. On a field walk of the ditch, D&A found that the ditch is filled to the east of the property, therefore only a small offsite area will collect in the ditch and be conveyed to the project site. This area has been included in the site watershed and has been accounted for in the project hydrology. Figure 6 shows the location of the cutoff (blockage) of the Main Ditch in relation to the project site. Figure 8 provides a view of the blockage location where the Main Ditch has been filled in. There were several other locations of blockage found when continuing to the east to Airport Road.

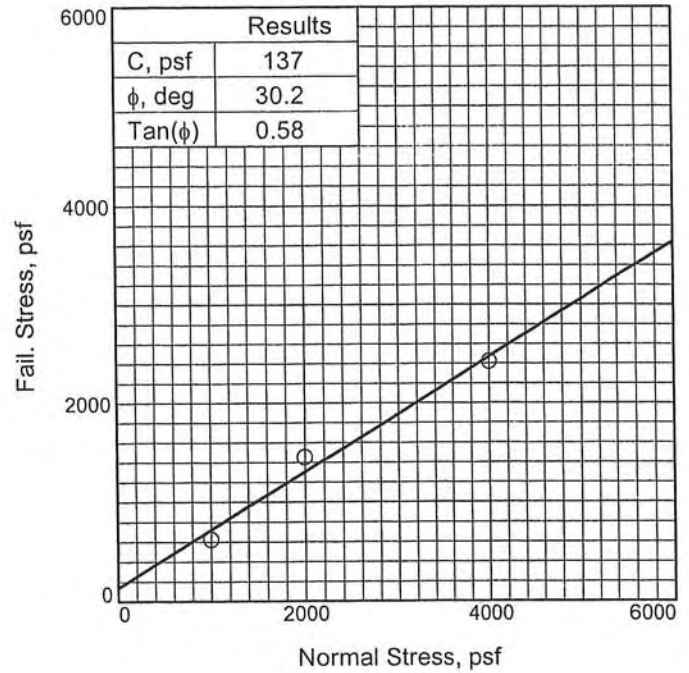
Sample No.	1	2	3
Initial			
Water Content, %	20.2	20.2	20.2
Dry Density, pcf	90.8	90.8	90.8
Saturation, %	73.0	73.0	73.0
Void Ratio	0.6767	0.6767	0.6767
Diameter, in.	2.500	2.500	2.500
Height, in.	1.000	1.000	1.000
At Test			
Water Content, %	26.8	26.0	25.0
Dry Density, pcf	92.1	93.2	94.6
Saturation, %	100.0	100.0	100.0
Void Ratio	0.6532	0.6348	0.6096
Diameter, in.	2.500	2.500	2.500
Height, in.	0.986	0.975	0.960
Normal Stress, psf	1000	2000	4000
Fail. Stress, psf	621	1452	2420
Displacement, in.	0.140	0.160	0.300
Ult. Stress, psf			
Displacement, in.			
Strain rate, in./min.	0.003	0.003	0.003

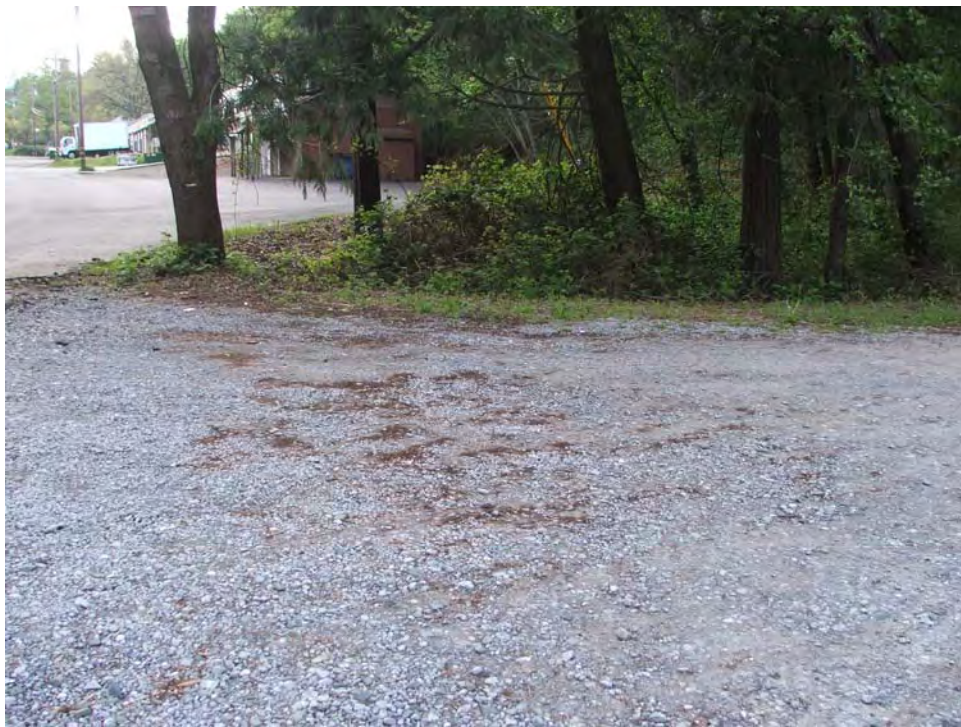
Photograph 9. Culverted area upstream of Canyon View Drive, previously filled crossing in the foreground.

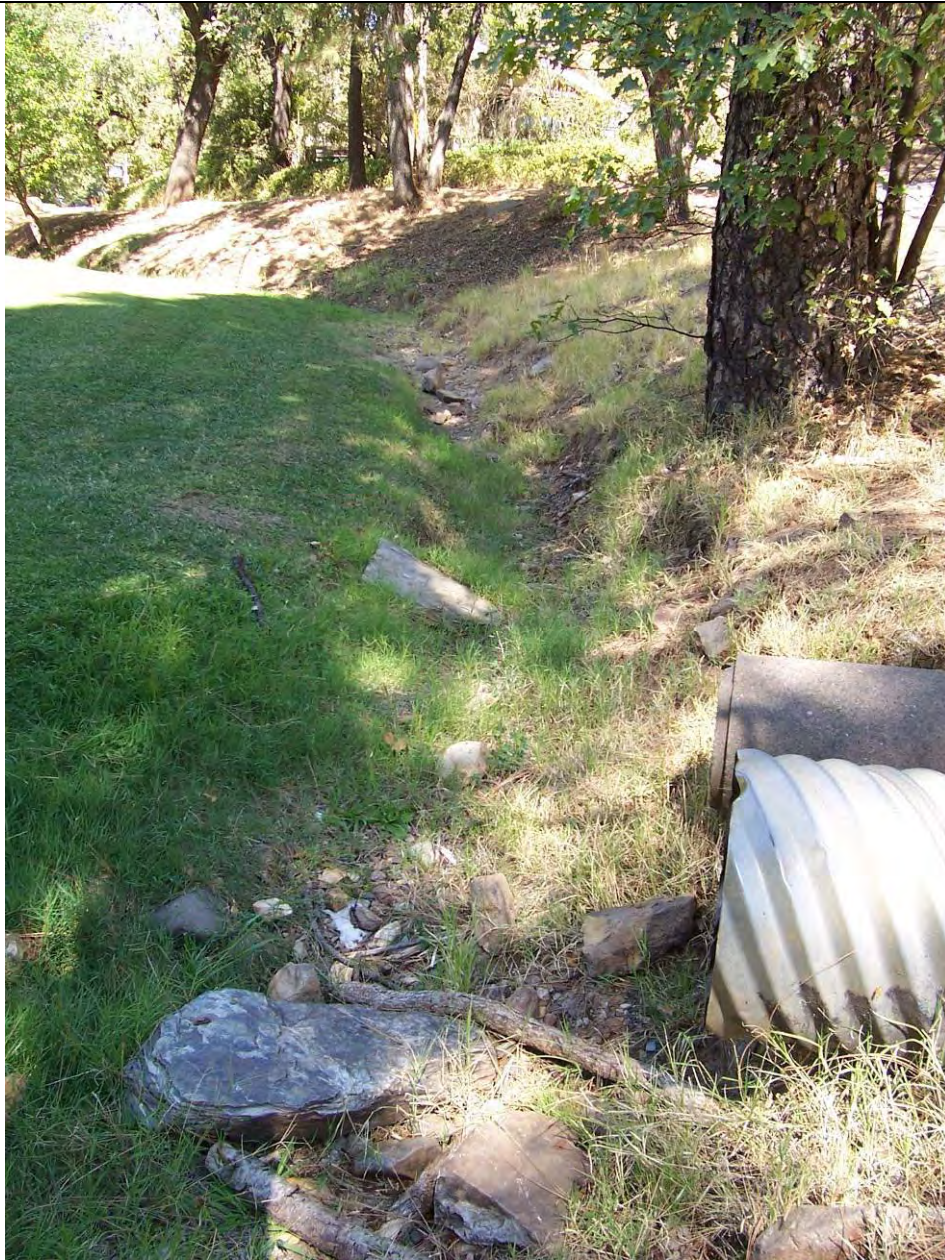
Photo 5: Modified channel downstream of 5-acre parcel, at Lumsden Park.

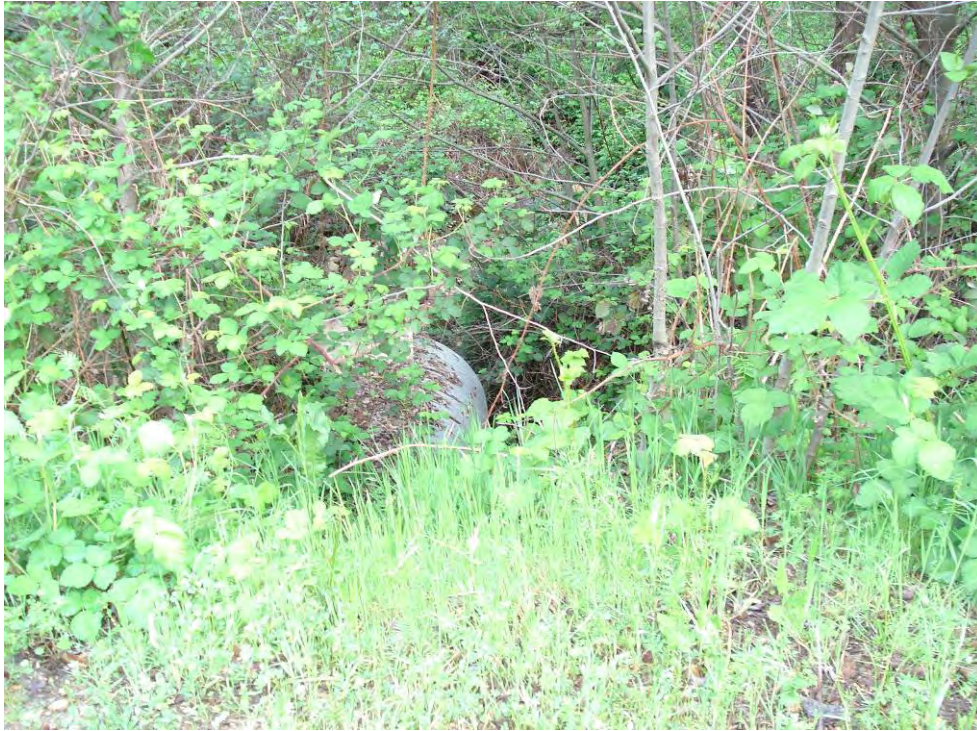
Photo 6: Culvert and drainage downstream (west) of dirt road (DR-5).
