# ROOF MEASUREMENT REPORT

487 Main St, Placerville, CA 95667

Date:	05/17/2018
Report:	22964960

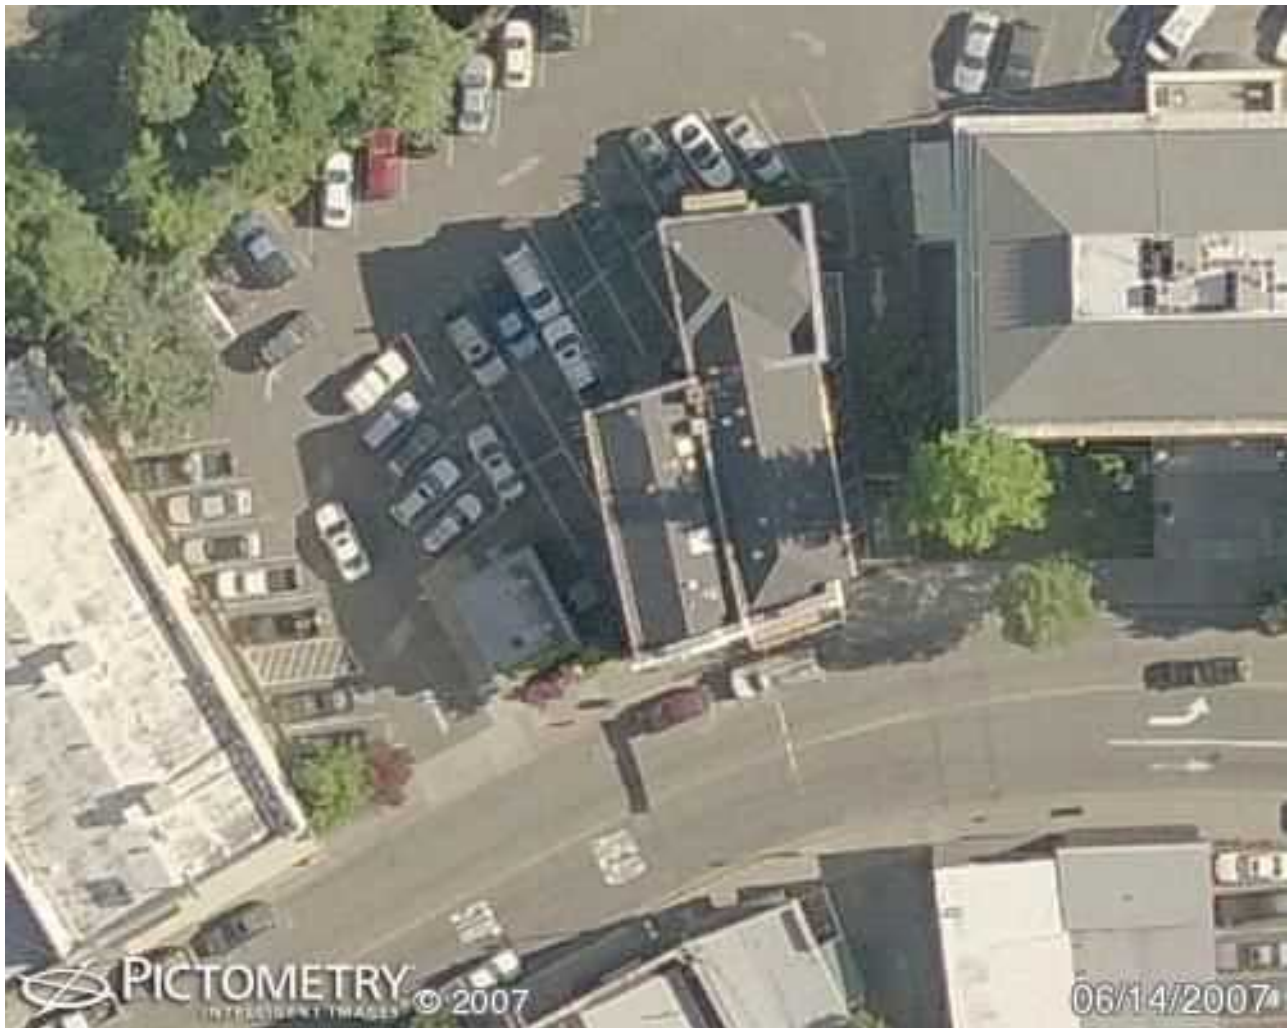
**Top View**

The following aerial images show different angles of this structure for your reference.
