# CITY OF PLACERVILLE POLICE DEPARTMENT & EL DORADO COUNTY FIRE PROTECTION DISTRICT COMBINED PUBLIC SAFETY FACILITY

## Space Needs Assessment & Feasibility Study

PLACERVILLE, CA | NOVEMBER 2022

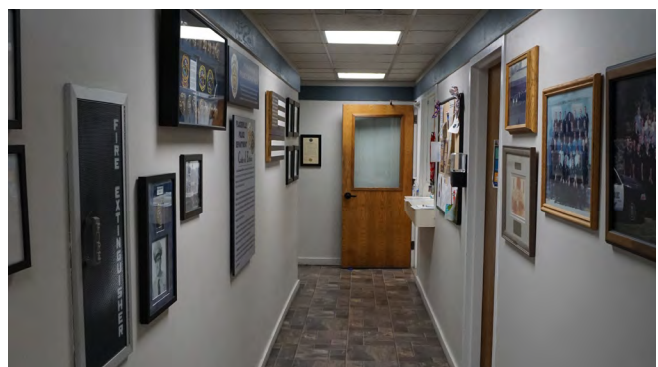
Typical narrow building corridors

- Insufficient space forces equipment placement into already narrow corridors, further impeding accessibility.
- No dedicated information technology (IT) space or server room. Servers are stored within already cramped workspaces.

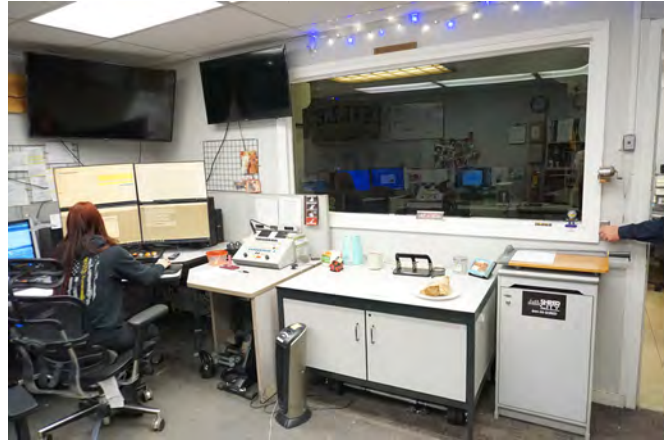
Dispatch area: privacy film toward lobby

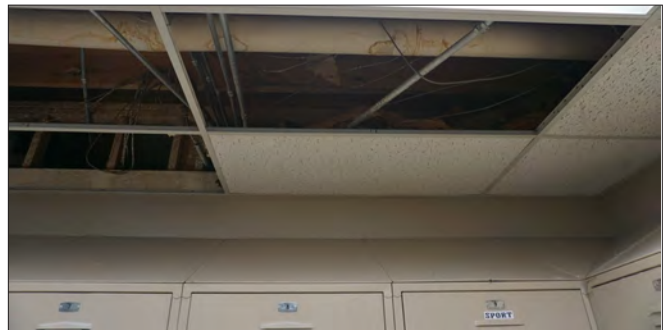
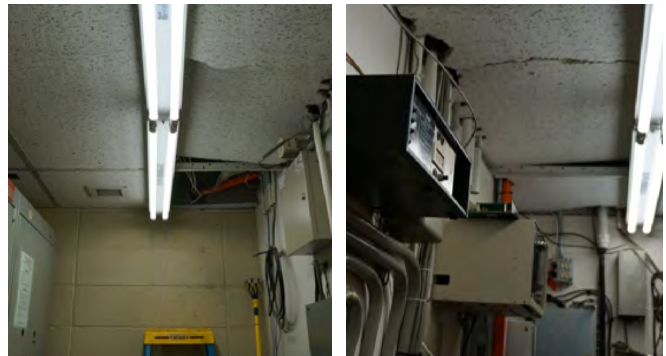
Damaged ceiling tiles with exposed wiring

- There is inadequate space to further develop or expand critical community programs.
- Data cables and wiring are exposed at the ceiling in multiple locations.

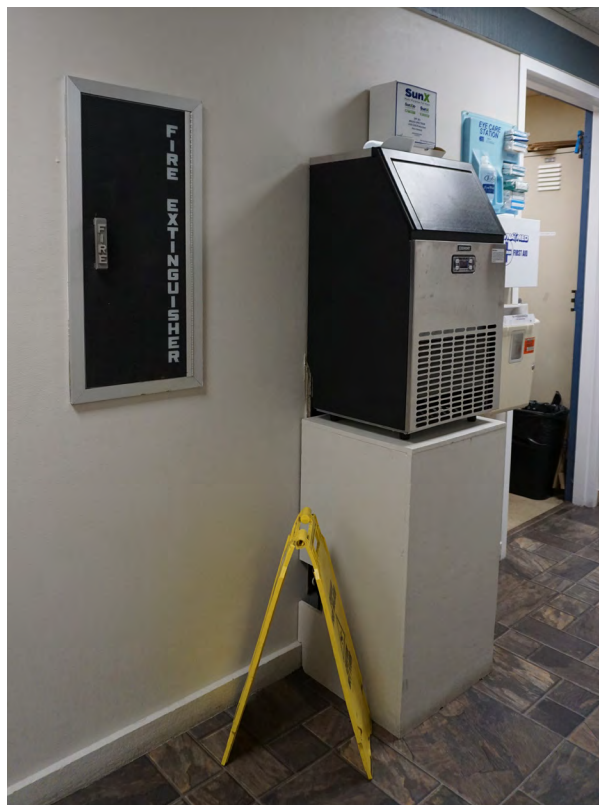
Lack of adequate space forces equipment to be placed in hallways.

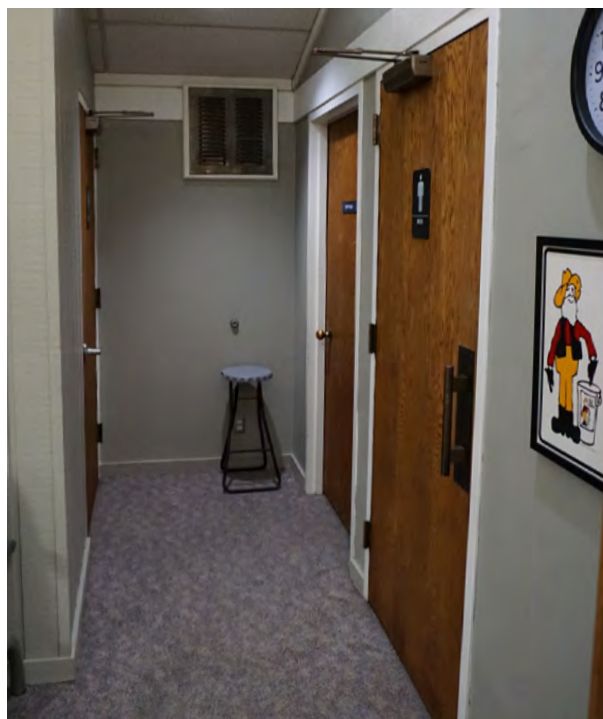
Public restroom access via blind corridor

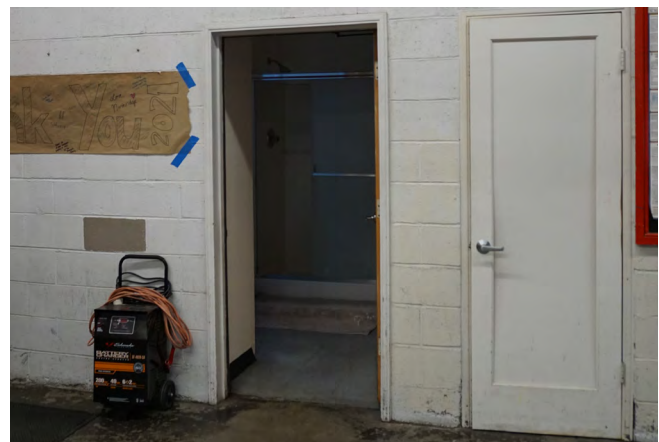
View from the apparatus bay into the firefighter bathroom and living quarters

- Living quarters are directly adjacent to the apparatus bay posing potential air quality risks to staff.

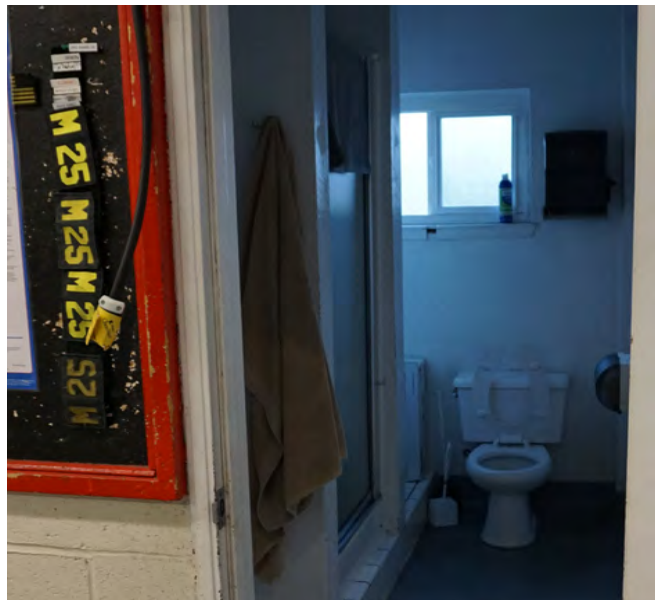
Public/staff restroom and shower off of apparatus bay.

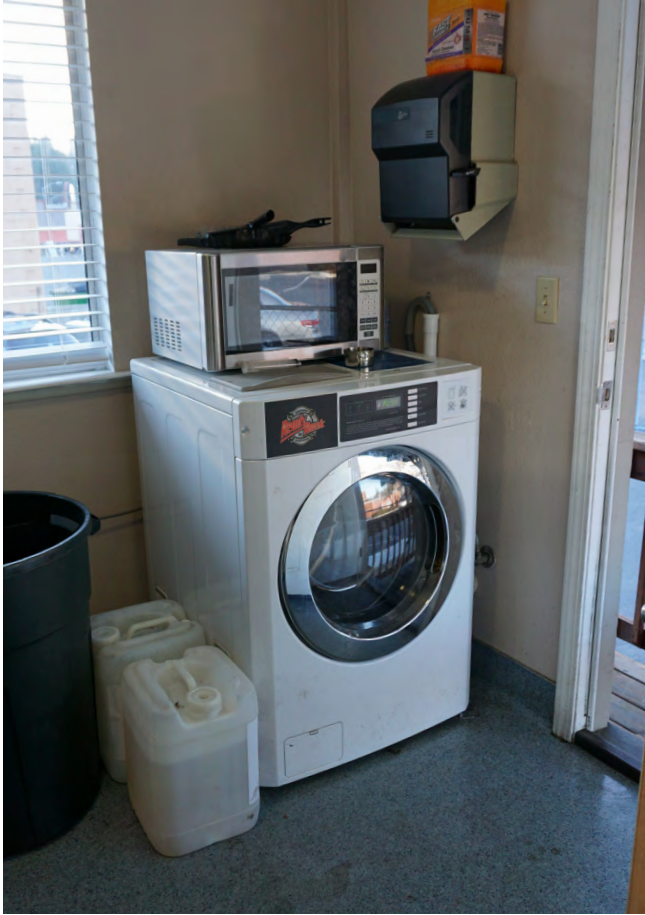
The laundry area and extractor are located in an enclosed porch space with the only access being through the kitchen and dining area risking potential exposure to chemicals, carcinogens, bodily fluids, and other sources of contamination from a fire or medical call.

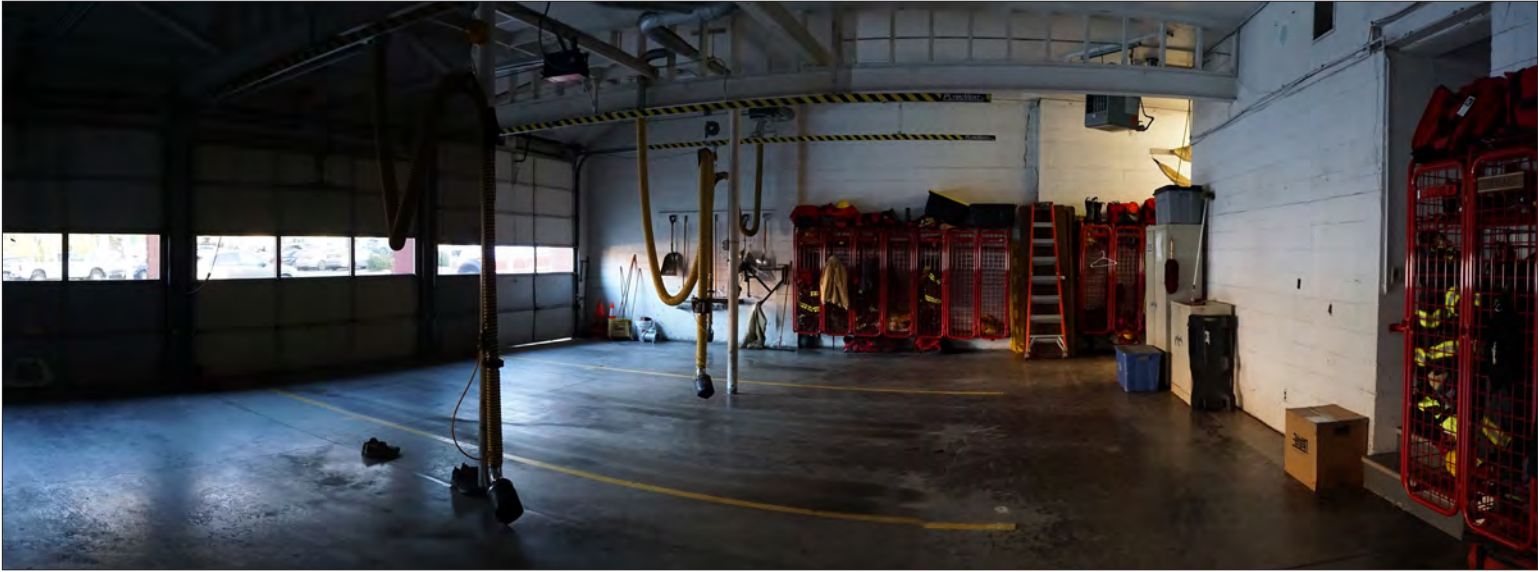
The height of the current apparatus bay prohibits maintenance of the engine indoors. The engine cab turnover can only be accommodated on the driveway apron immediately fronting Sacramento Street.

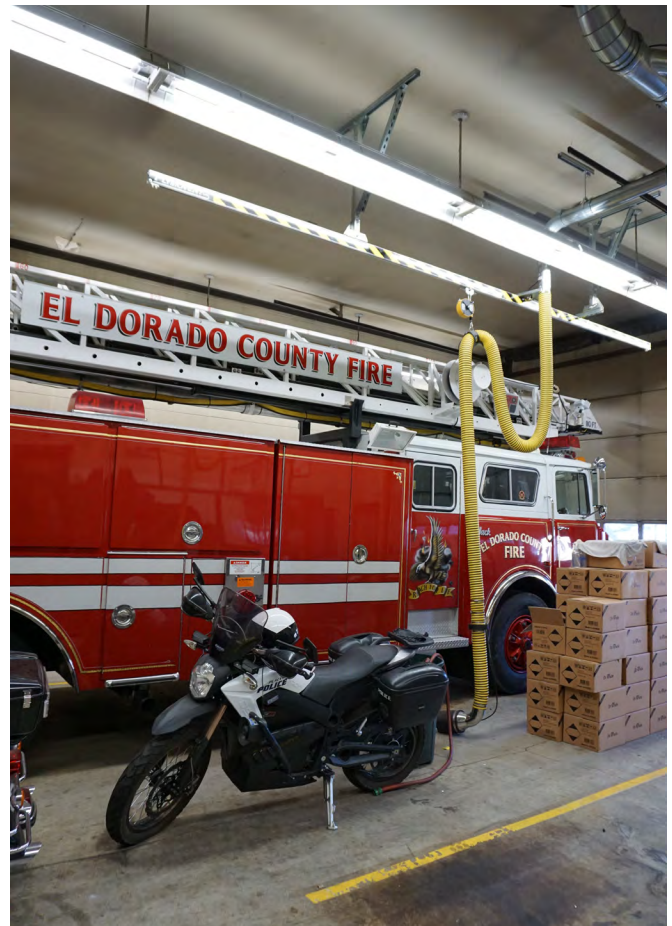
The apparatus bay is undersized for modern engines and equipment. It's also utilized for storage of turnouts, additional drying space, and a makeshift emergency shower stored in an old closet space.

- Vertical expansion is not possible due to structural and foundational deficiencies of the facility.
- Apparatus bay is significantly undersized for modern engines, ambulances, support gear, equipment, and miscellaneous department supplies.
